*Newlands Corner  
and  
Merrow Downs*

*A survey of the yews*

Peter Norton August 2012

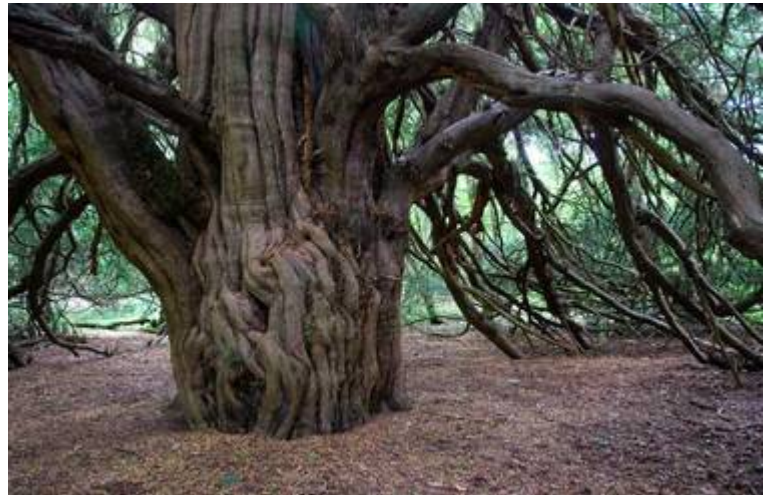
TQ0413149530 M 16' 8" at 1'  
2 leaders from a 5' break of crown, major layering evident, 1 embedded nail

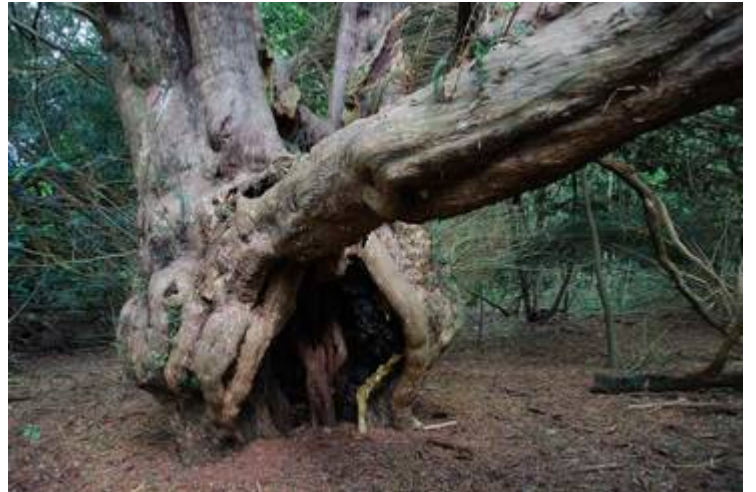
TQ0410449596 M 15' 7" at root crown  
Large cavity, internal growth, hollowing branches, major layer though host branch has withered

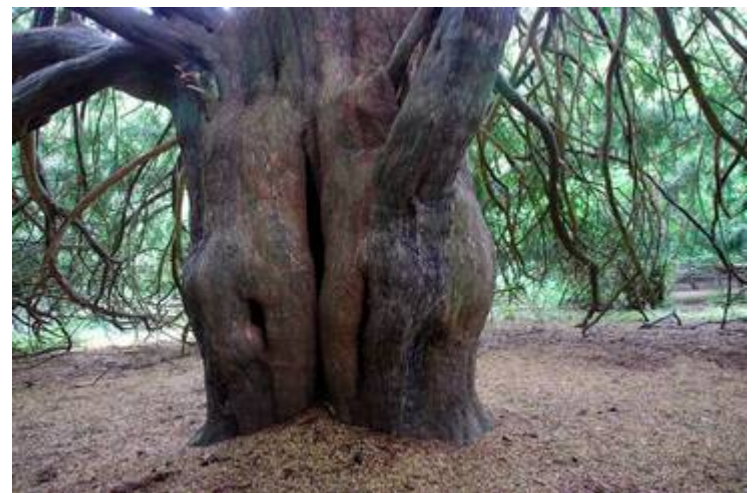
TQ0408649609 M 14' 9" at root crown  
Hollow but no internal stem

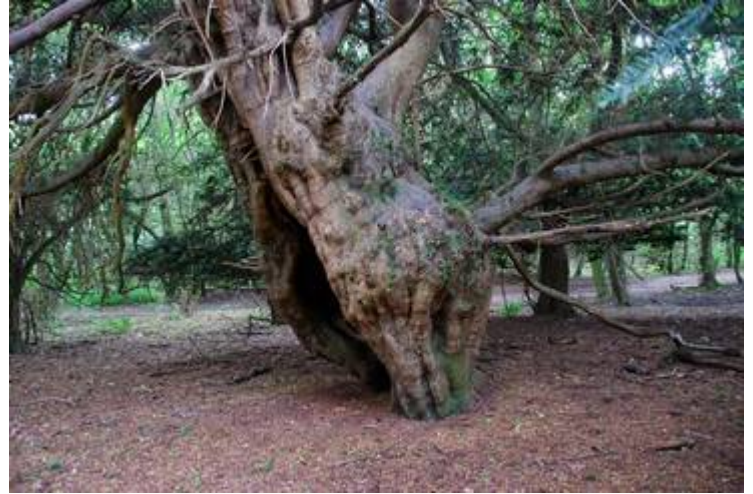
TQ0407849595 F 10' 9" at root crown  
Loss of outer shell has reduced girth

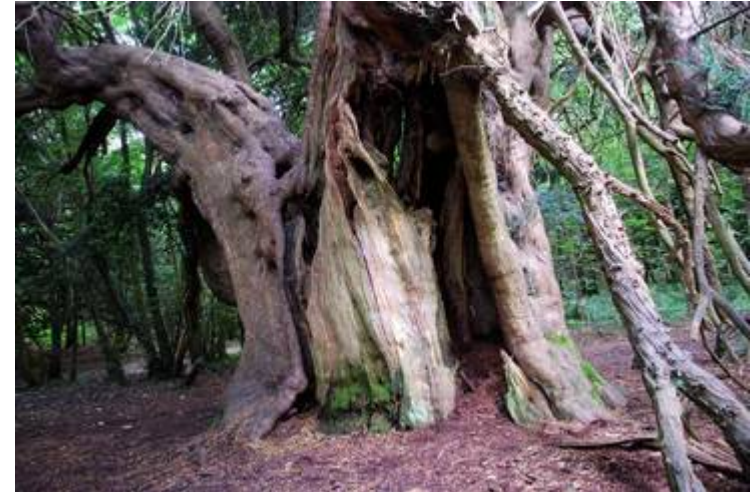
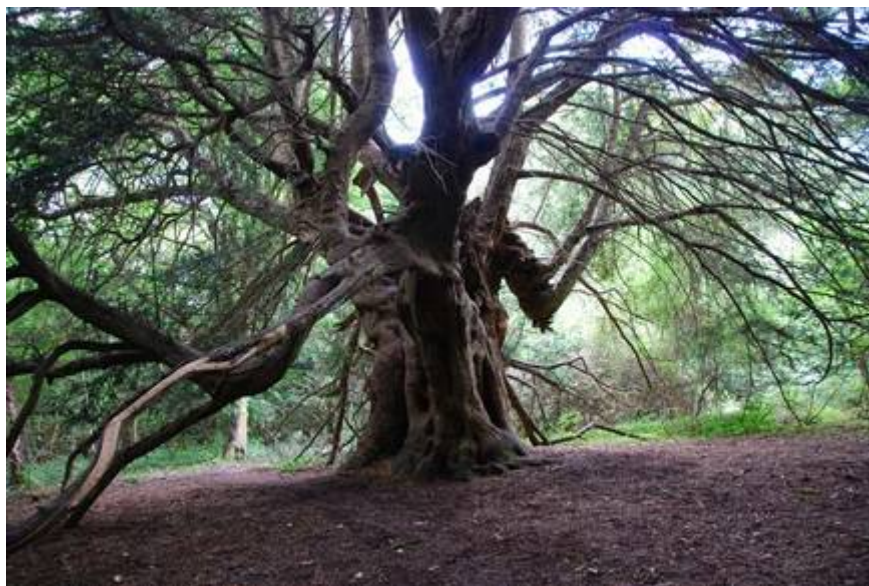
TQ0406549593 F 22' 4" at 2'  
Hollow and fragmented, girth includes buttress remnant, many seedlings, three embedded nails

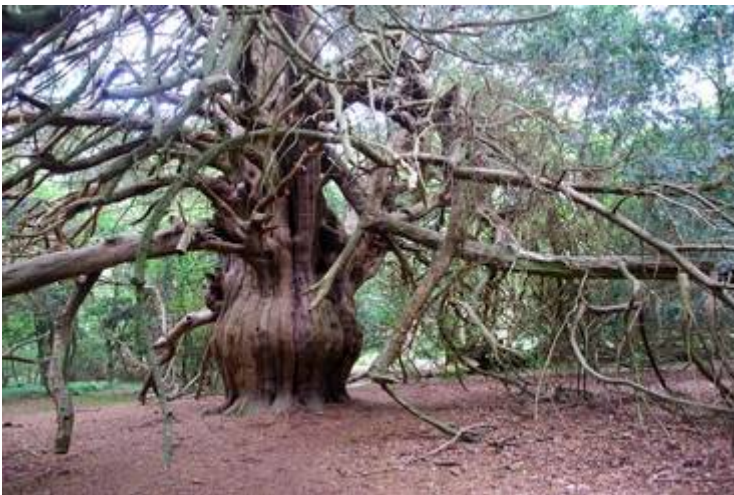
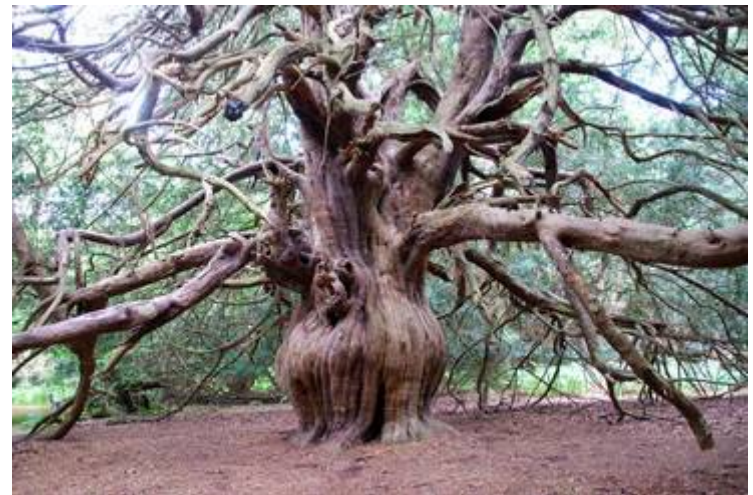
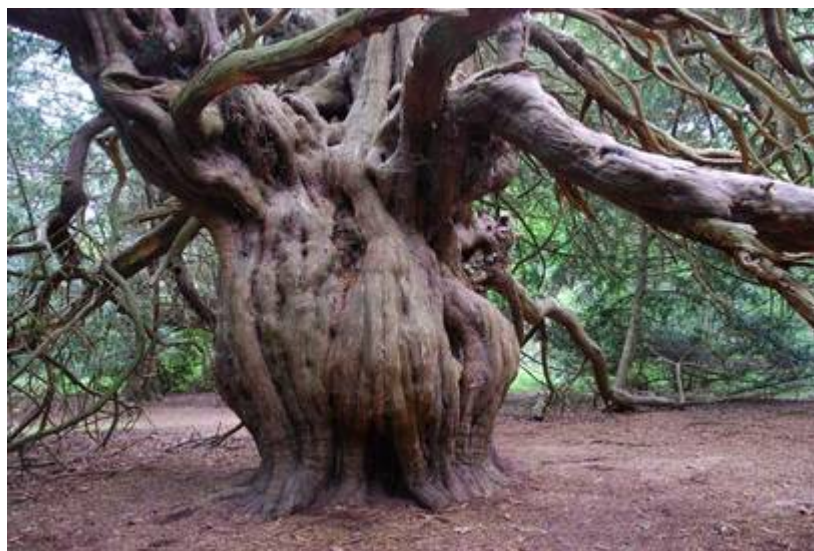
TQ0403849605

Sparse foliage, appears to be hollowing. Two embedded nails at the height measured. Looking closely at the third photograph, new flow of wood up to a foot thick has almost covered the remains of a cut branch resulting in this bulbous appearance. This flow of wood is noted on many of the Urn shaped yews.

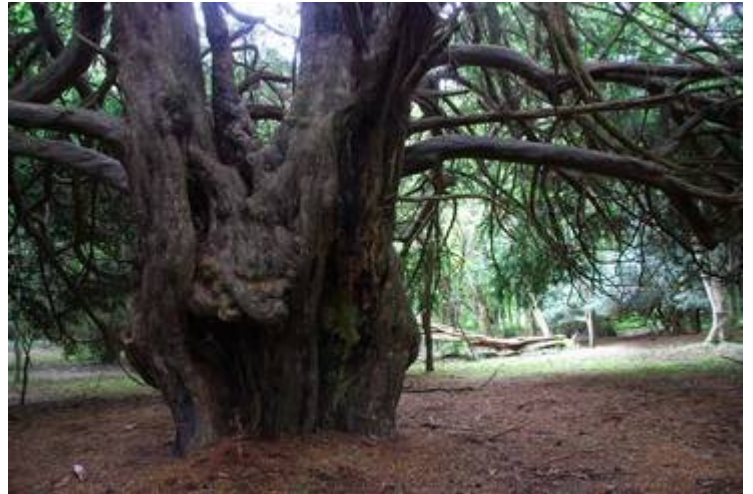
TQ0403249592 M 14' 4" at root crown  
Urn shaped with loss of outer shell, small internal growth

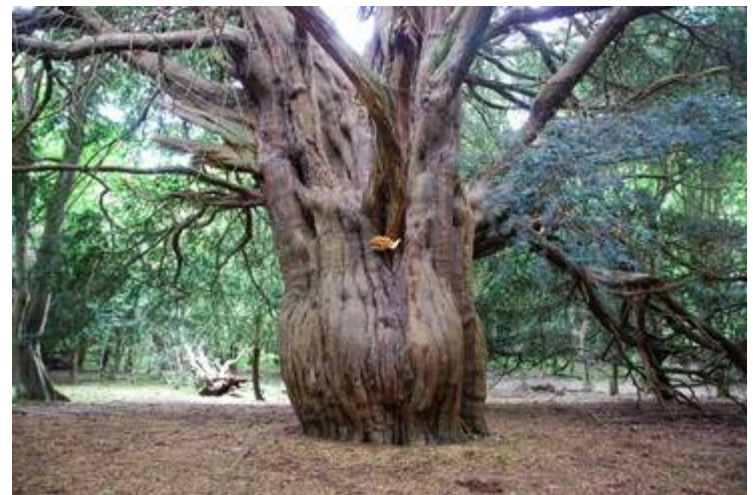
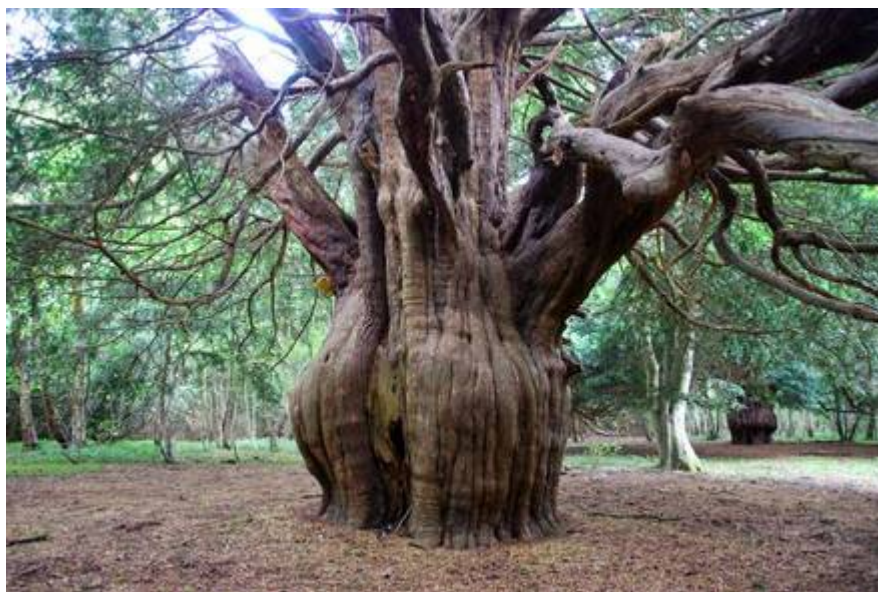
TQ0399049562 M 19' 9" at root crown  
Possibly hollow, sparse foliage and again note the cut branch and the flow of new wood in the third photograph

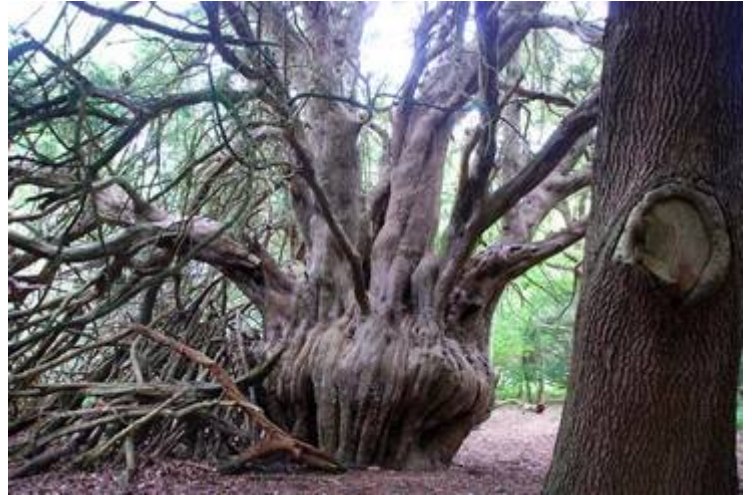
TQ0398749603 M 16' 8" at ground  
Hollowing branches from a 5' break of crown

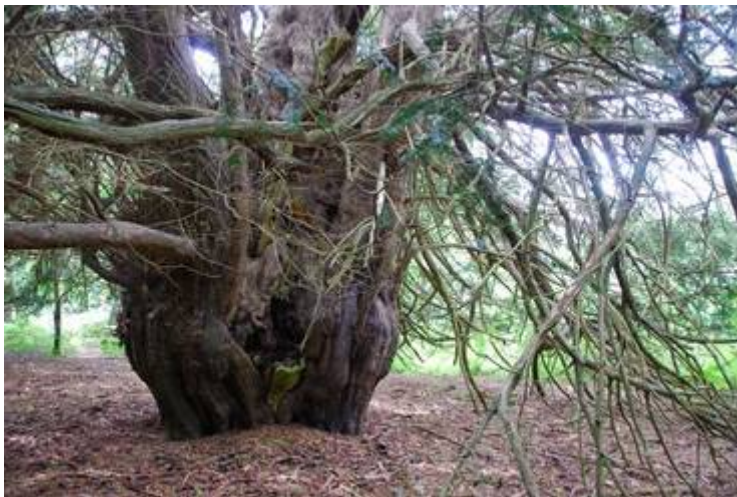
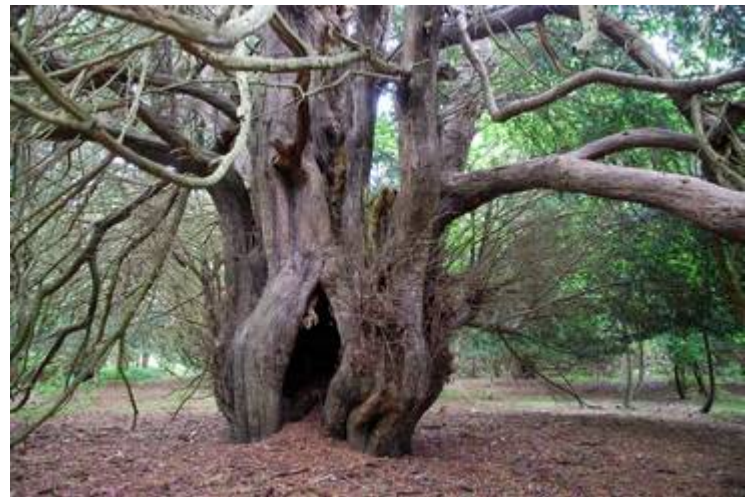
TQ0396849615 M 17' 1" at 6"  
Hollow but no internal stem

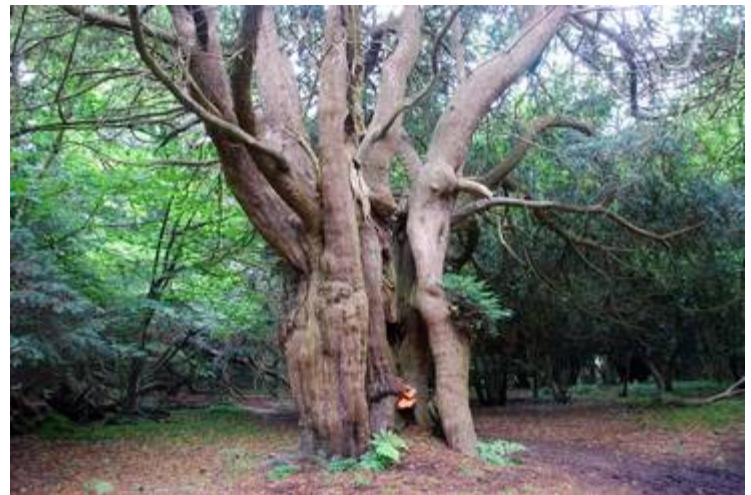
TQ0401949627 M 14' 11" at 1'  
Fragmented in 3 sections

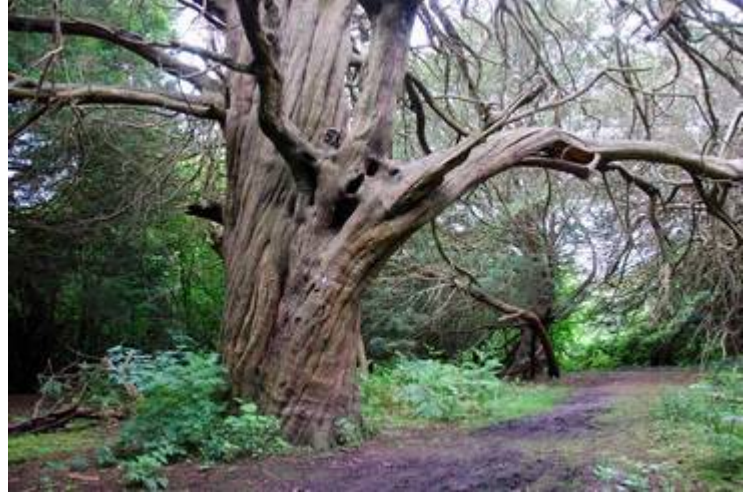
TQ0401549617 16' 2" at 1'  
Possibly dead, no foliage, unable to sex

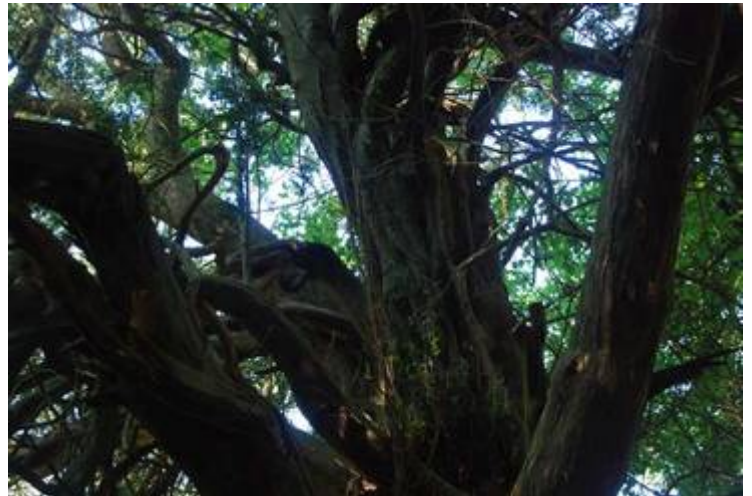
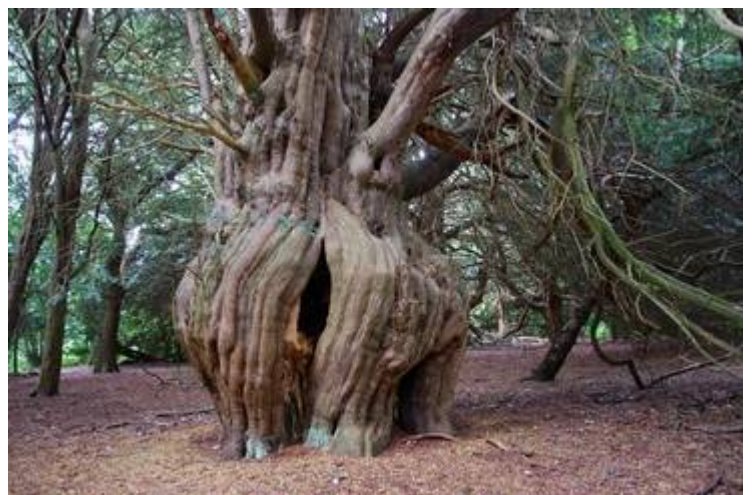
TQ0401949633 F 17' 11" at root crown  
Hollow, internal stems, many seedlings. Whitebeam grows from the canopy on the main leader with roots having reached the ground through the bole of the yew. Third photograph shows the yew roots on the right while those on the left are from the whitebeam. Fourth photograph indicates a cut branch being covered with new wood.

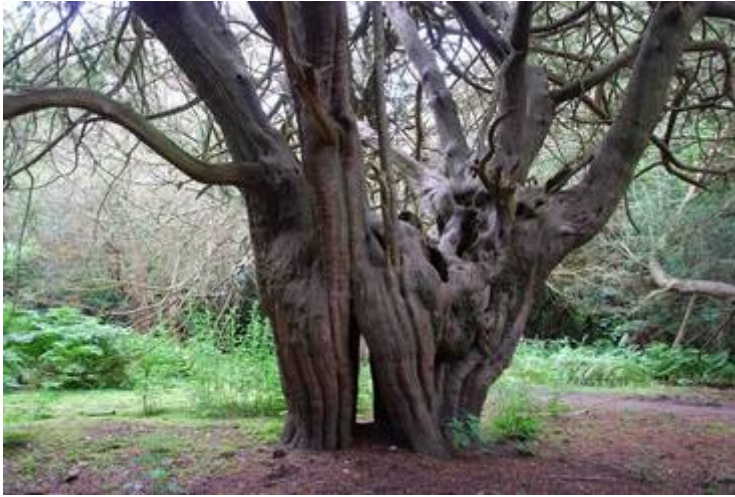
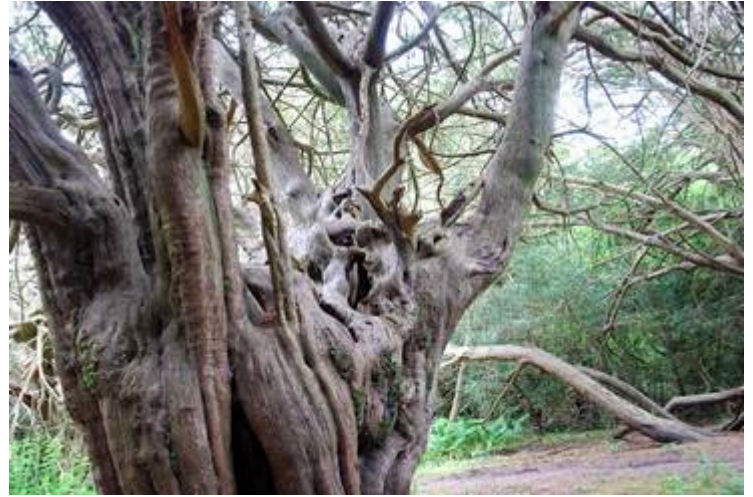
TQ0399549633 M 14' 9" at 1'  
Hollow, fragmenting with branches hollowing

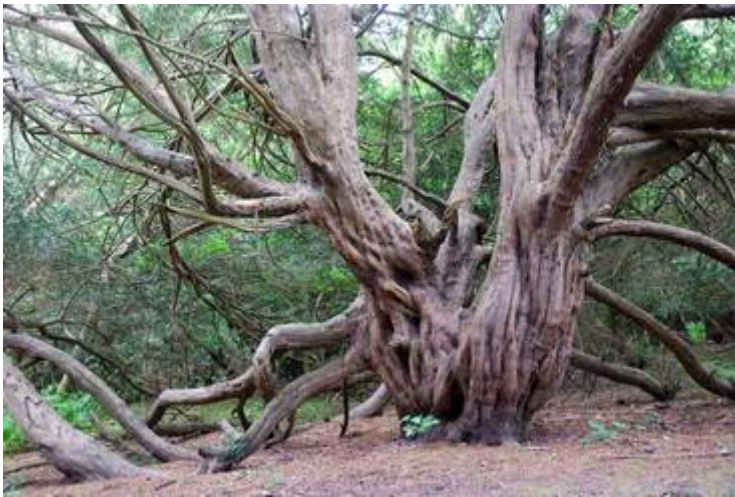
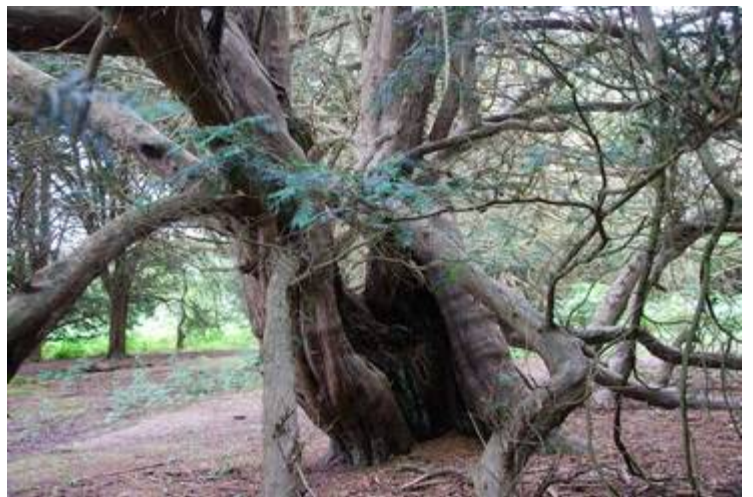
TQ0399049631 M 11' 9" at 6"  
Twin bole, loss of outer shell, hollow, 7 major layers

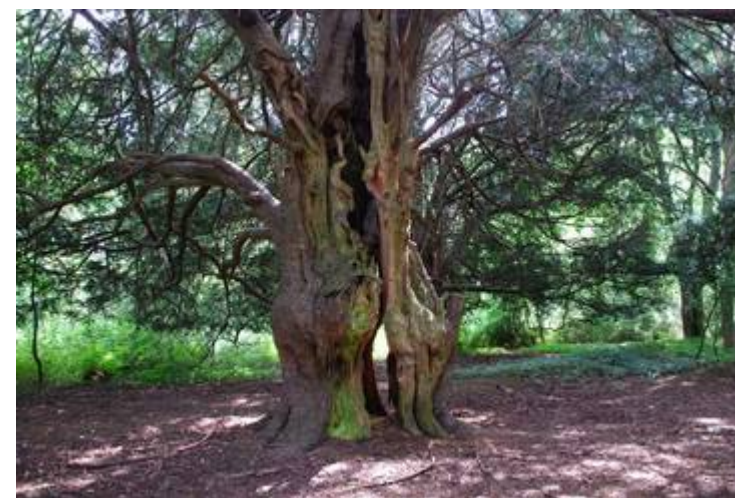
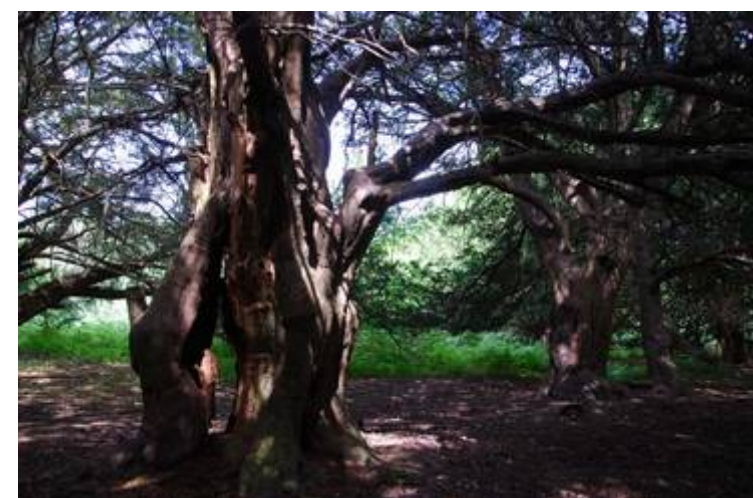
TQ0390049609 F 15' 5" at root crown  
Splitting into two halves, hollow, growing on the parish boundary bank along with others

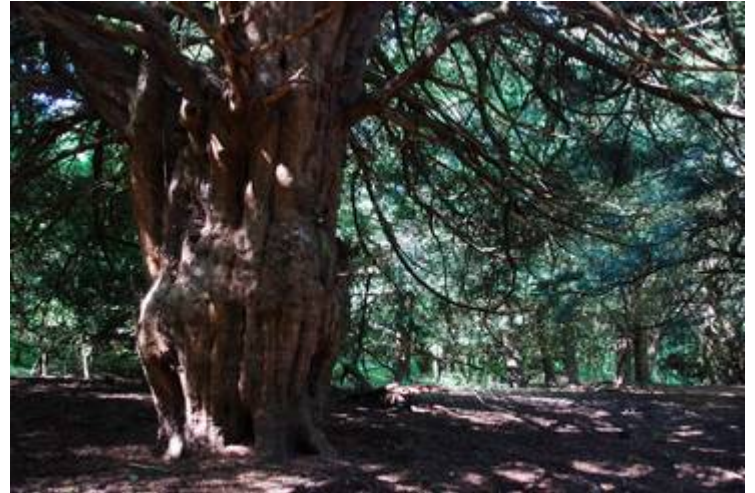
TQ0374149632 F 12' 5" at root crown  
Hollow with small internal stem

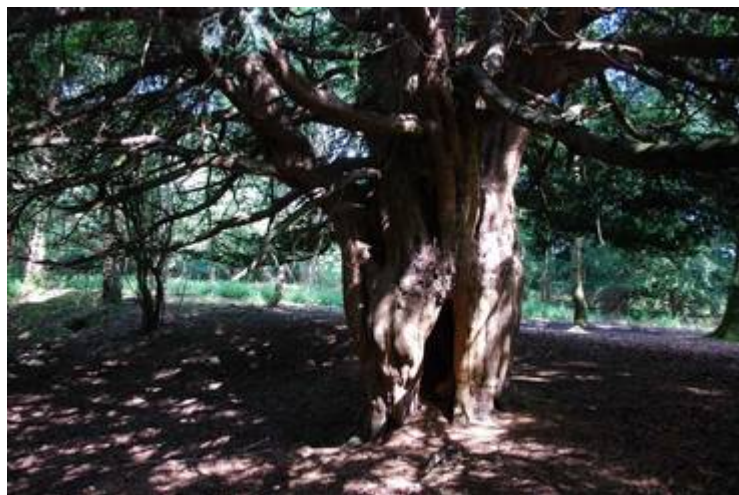
TQ0365449822 F 13' 8" at root crown, hollow

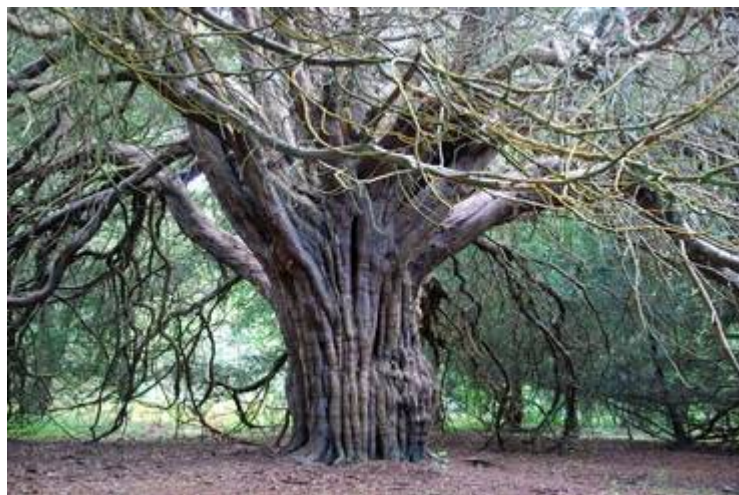
TQ0425649900 M 19' 1" at root crown  
Hollowing, having an 8' break of crown along with sparse foliage

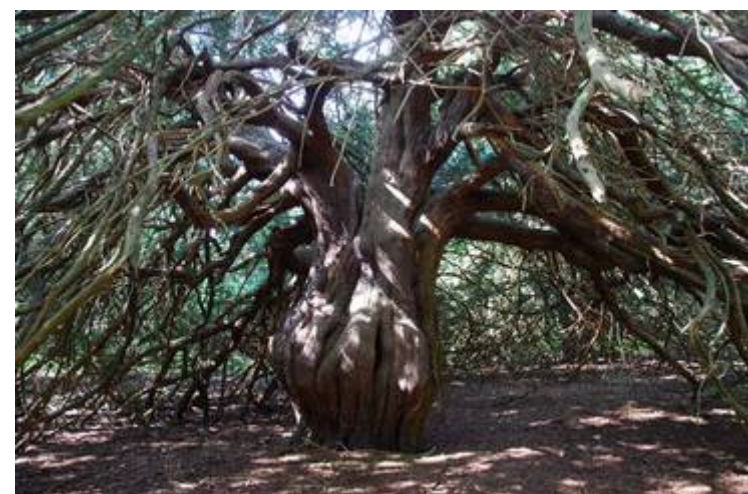
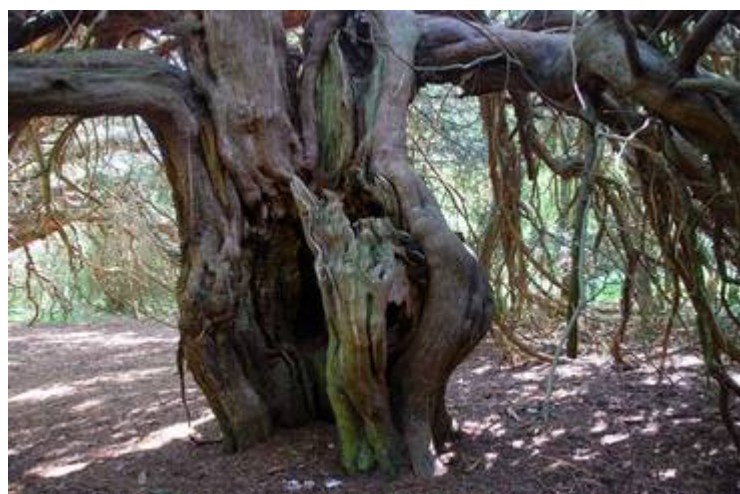
TQ0423749890 F 13' 1" at root crown  
Hollow and fragmented along with sparse foliage. Note the cut branch and flow of new wood in the second photograph.

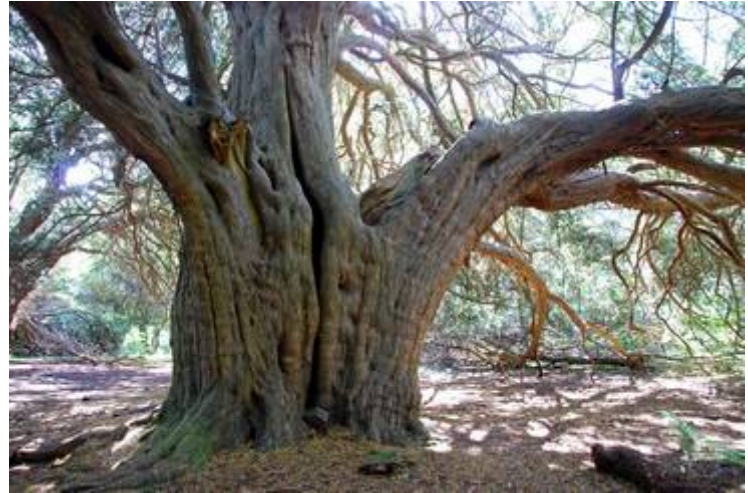
TQ0424949923 M 20' 10" at 2'  
Splitting into two halves, hollow, no sign of internal growth, also recorded 21' 5" at root crown

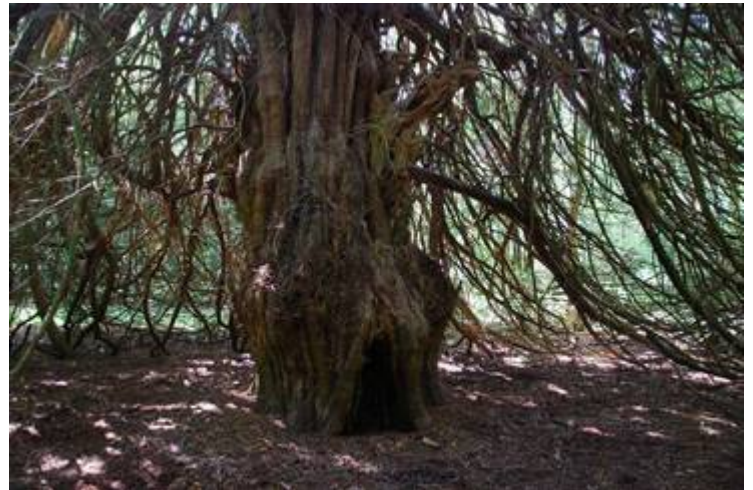
TQ0420949930 M 14' 4" at root crown  
Hollowing

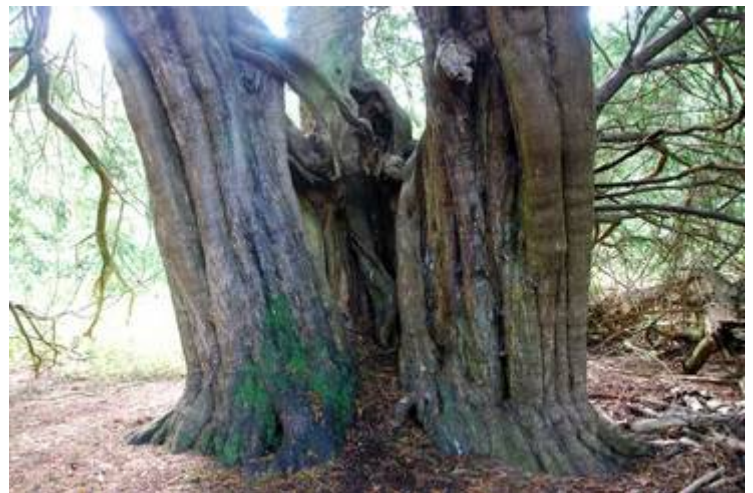
TQ0425249948 M 20' 2" at root crown  
Large internal stem

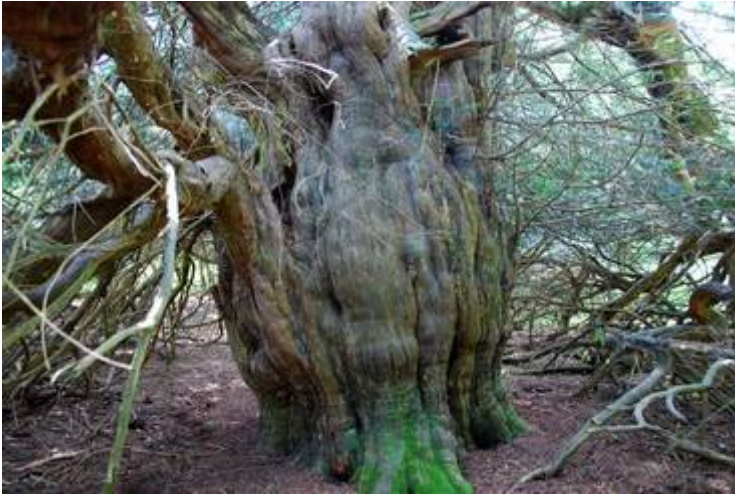
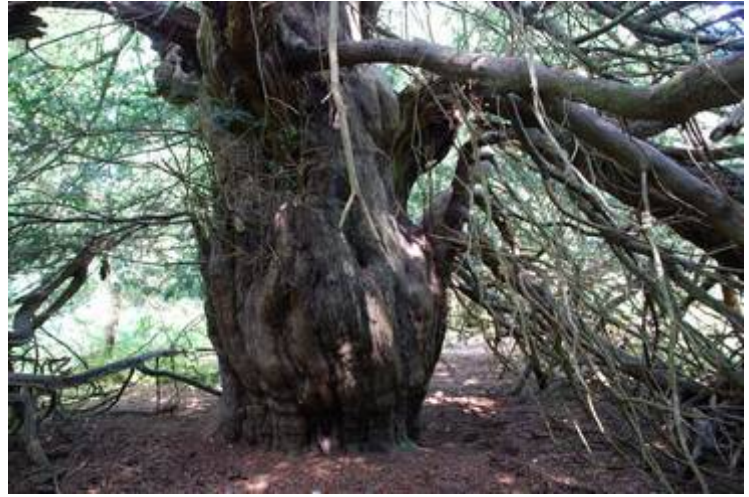
TQ0425649942 F 14' 2" at root crown  
Many lost branches

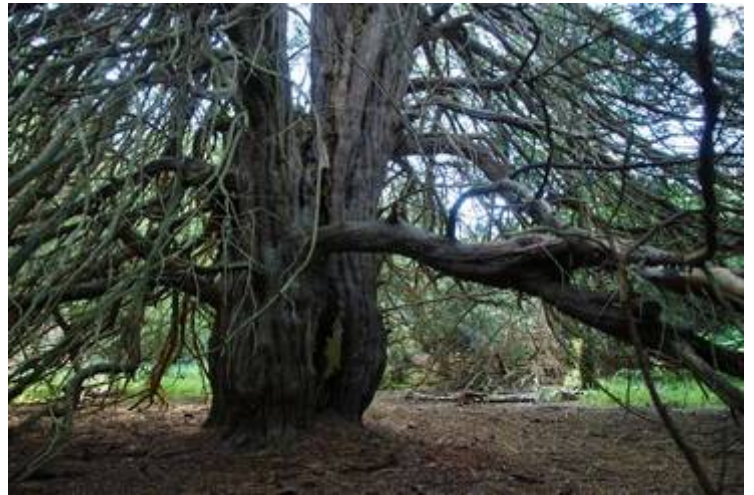
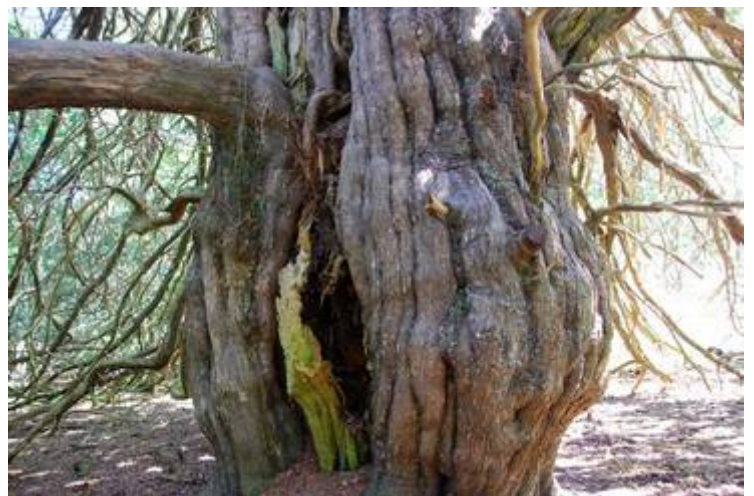
TQ0418649937 M 16' 6" at root crown  
12' break of crown, 4 leaders, hollowing, fragmenting, also note the cut branch and flow of new wood

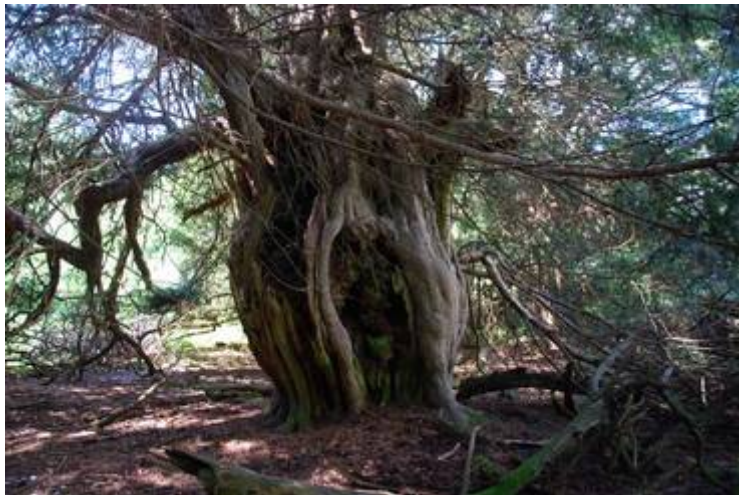
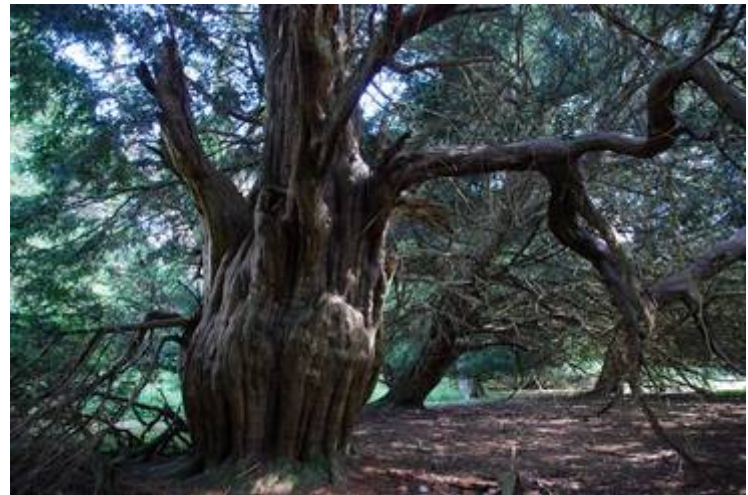
TQ0423349996 F 15' 3" at root crown

Hollowing, fragmented, sparse foliage

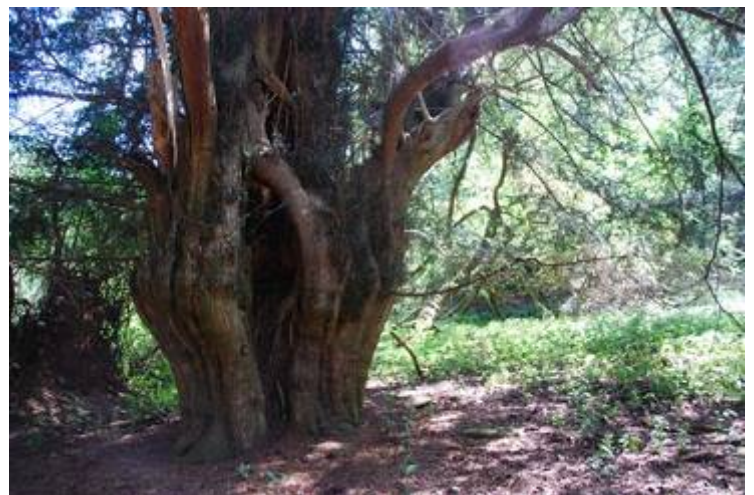
TQ0424150002 F 10' 9" at root crown

Hollowing, internal stem, cut branch and new wood

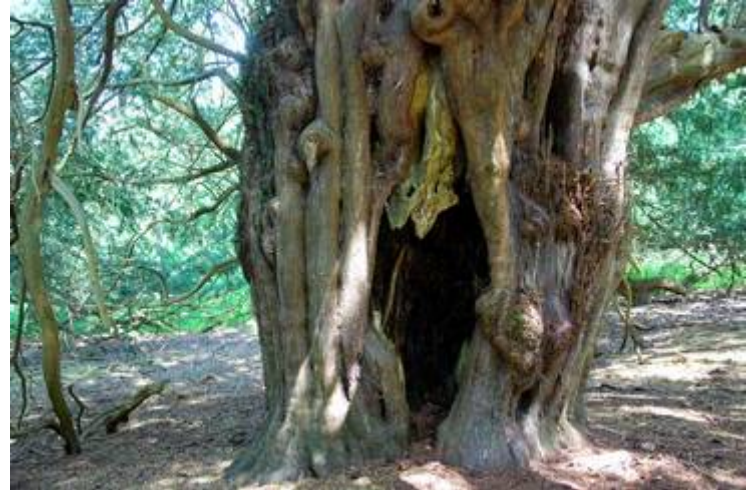
TQ0424450005 M 16' at root crown  
Hollowing, fragmented, sparse foliage, loss of branches, small internal roots

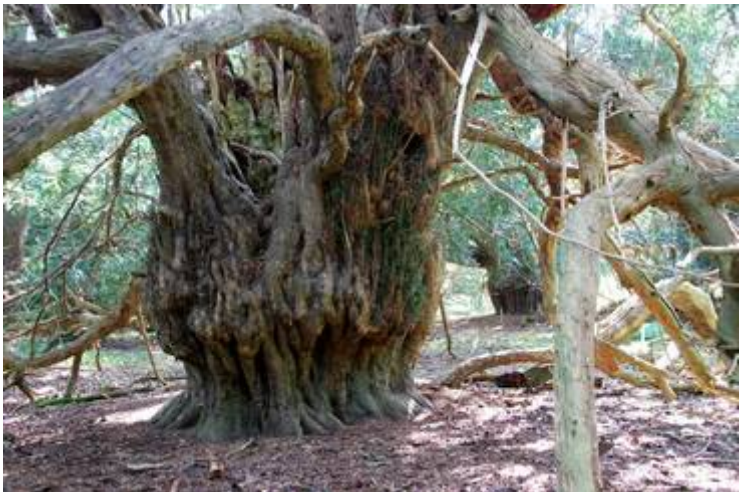
TQ0423850022 F 15' 2" at root crown  
Hollowing

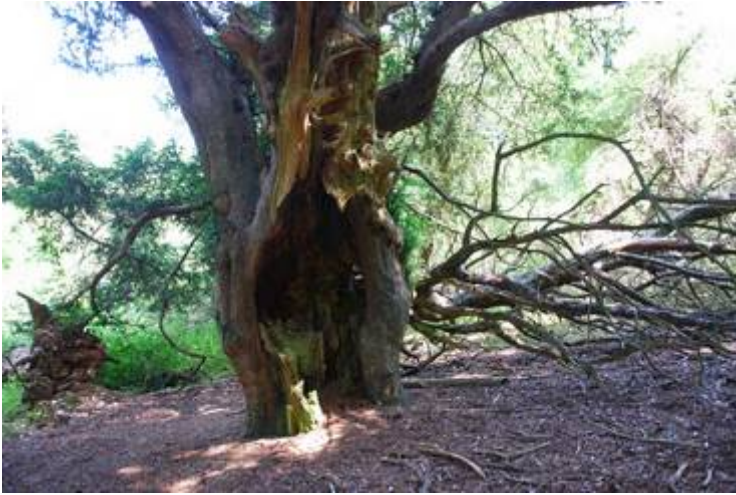
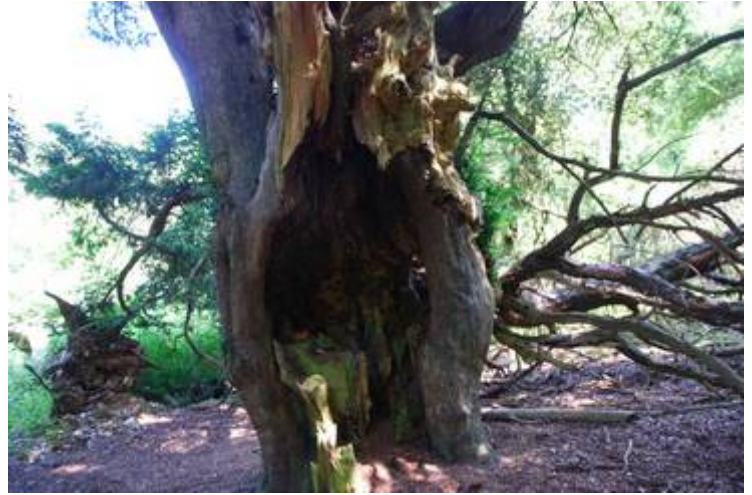
TQ0418749992 F 10' 8" at 1'

Large amount of rot, loss of outer shell - smaller yew in similar state close by

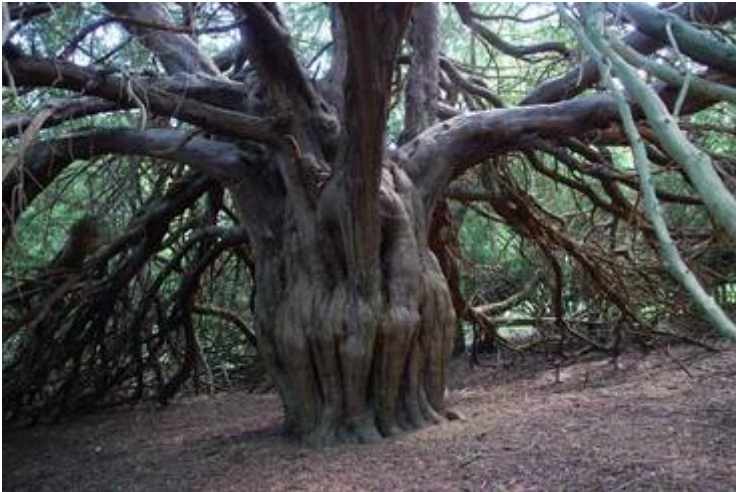
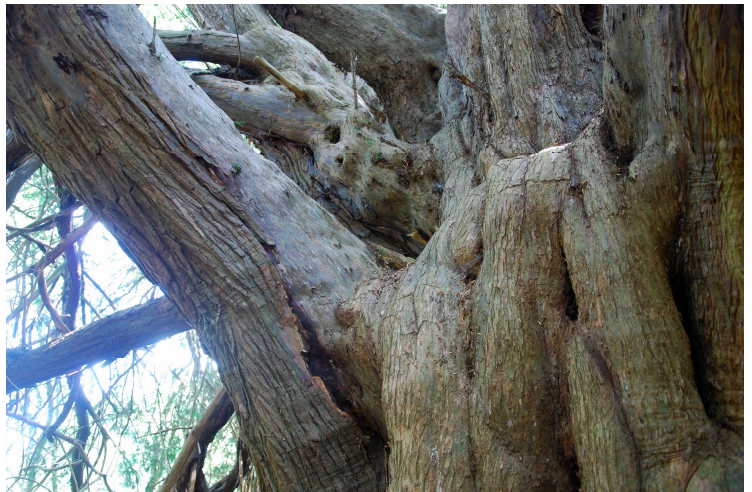
TQ0418249976 M 14' 6" at root crown

One branch has grown new bark underneath the old bark and rotted cambium

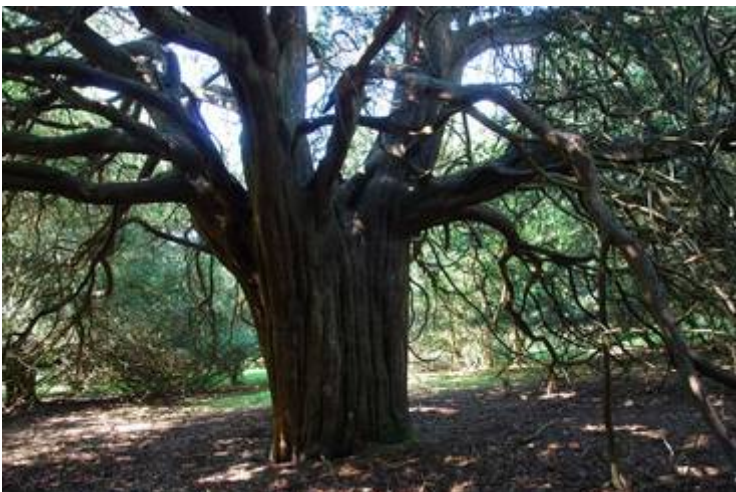
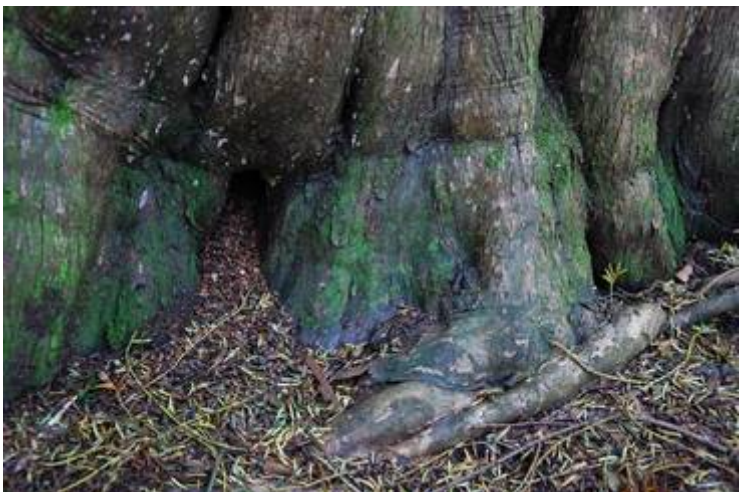
TQ0414150016 F 13' 1" at 1'

Note the mass of broken seed - probably a larder hoard for a wood mouse

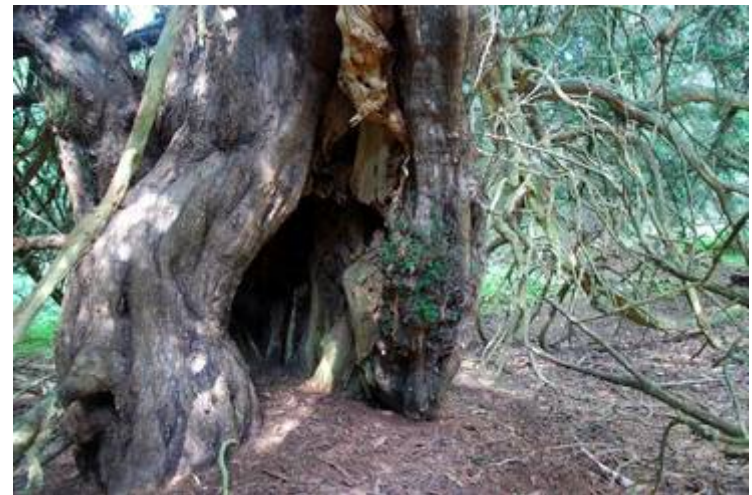
TQ0421950139 M 16' 10" at root crown  
Major loss of outer shell and totally hollow

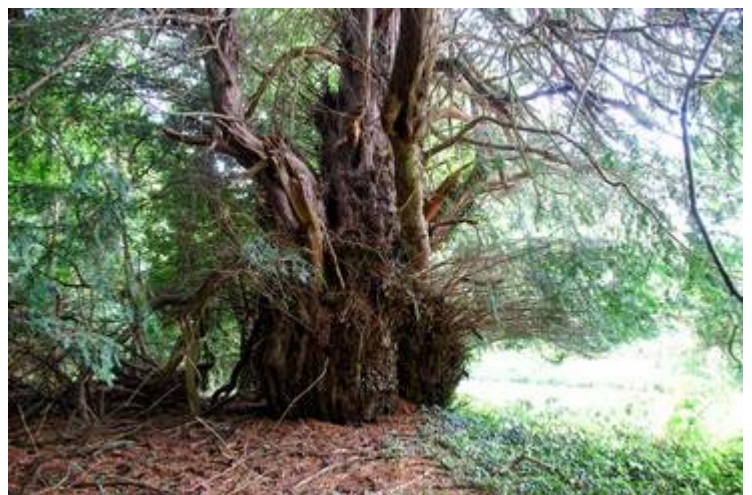
TQ0417549616 F 22' 10" at ground  
Roadside yew, difficult to measure due to lower twiggly growth, tape was threaded behind but girth recorded  
can only be used as an indicator

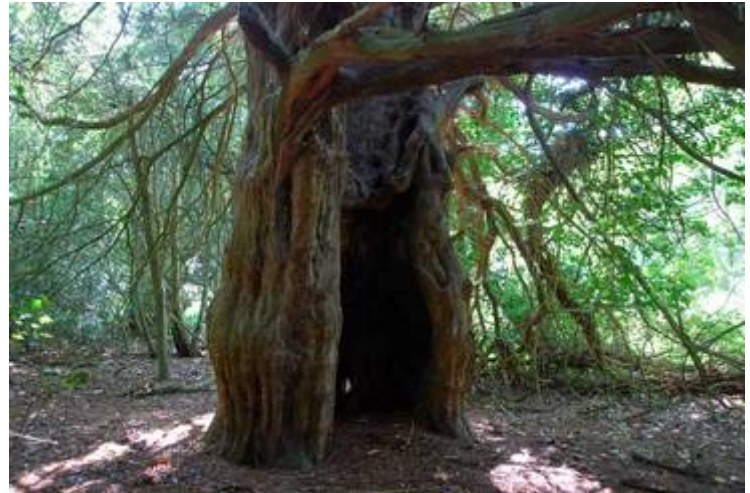
TQ0418849615 M 17' 8" at root crown

Roadside yew, hollow with loss of outer shell, no internal stem and 2 small basal cavities close to the ground

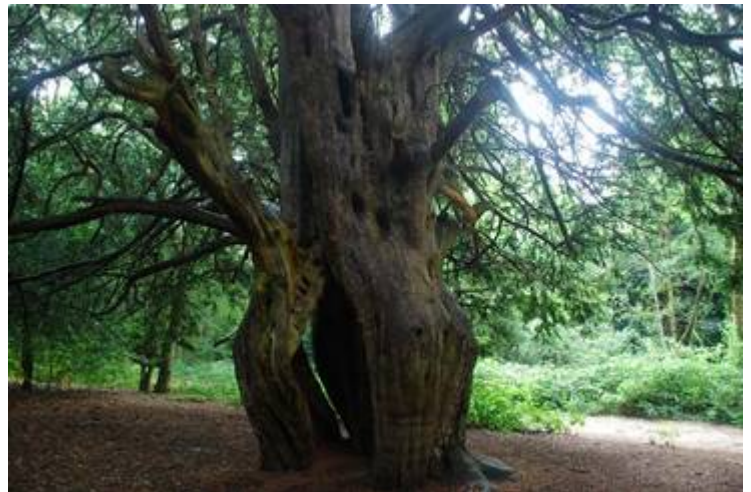
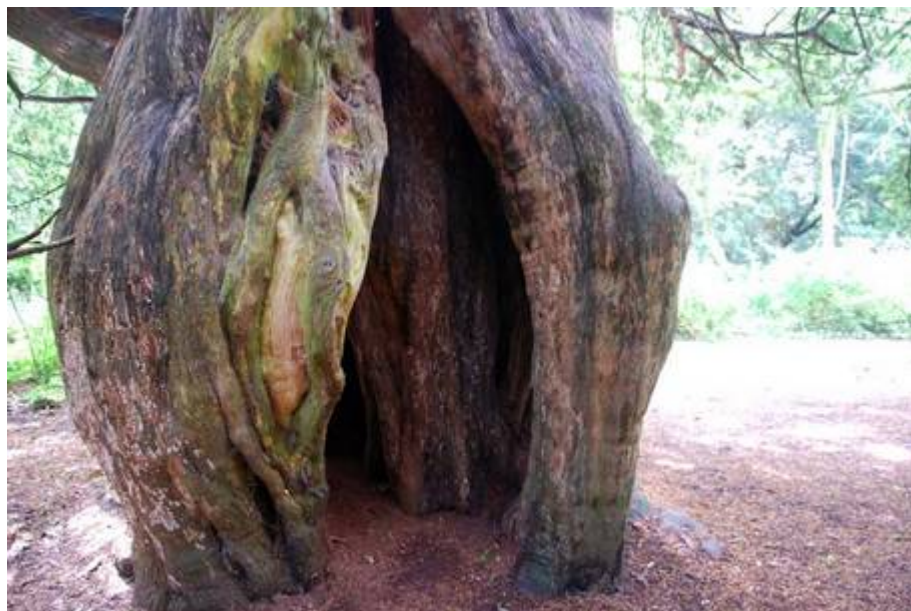
TQ0339149194 F 15' 5" at root crown

Urn shape, hollow and in 3 sections, large central stem that girthed 4' 2" at 1' 6" from the ground, 2 embedded nails, grows close to footpath

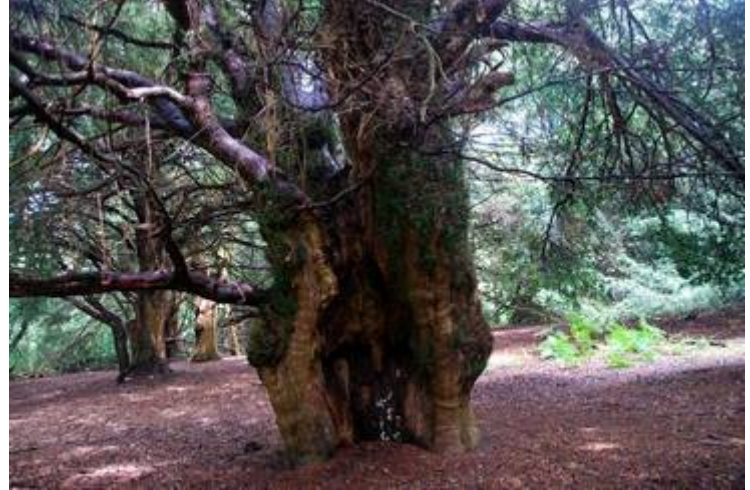
TQ0340849202 F 11' 11" at root crown  
Hollow, major loss of outer shell, no internal stem

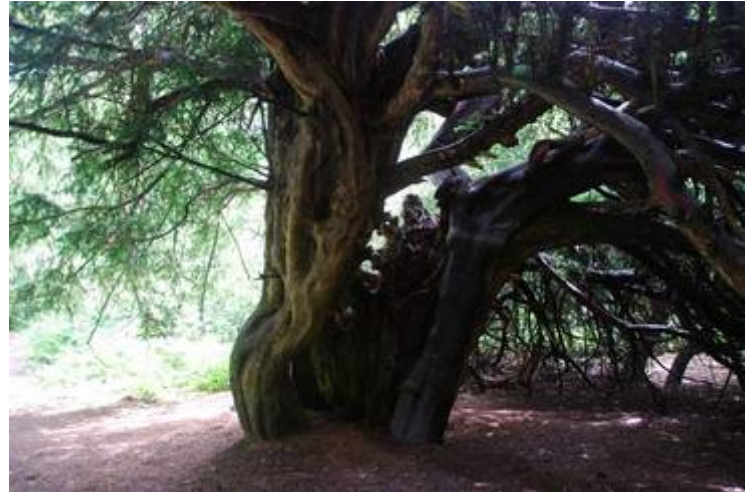
TQ0333349176 M 15' 7" at root crown and ground  
Major branch loss, fragmented with 2 main sections, undulating tape to get minimum girth, grows on the linear bank (parish boundary)

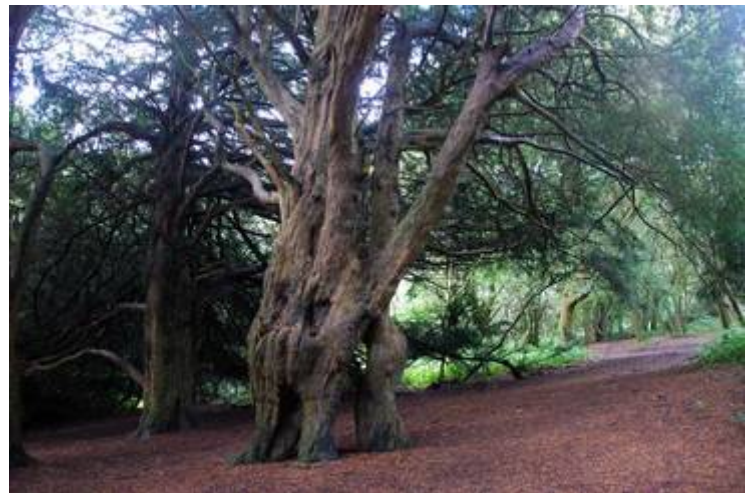
TQ0325649138 M 12' 6" at root crown  
3 segments, hollow, close to the west car park
