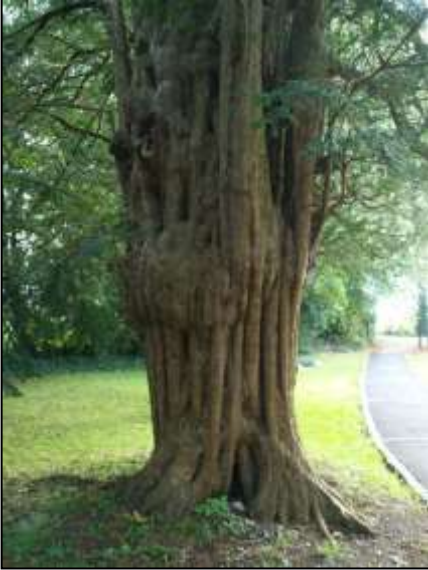
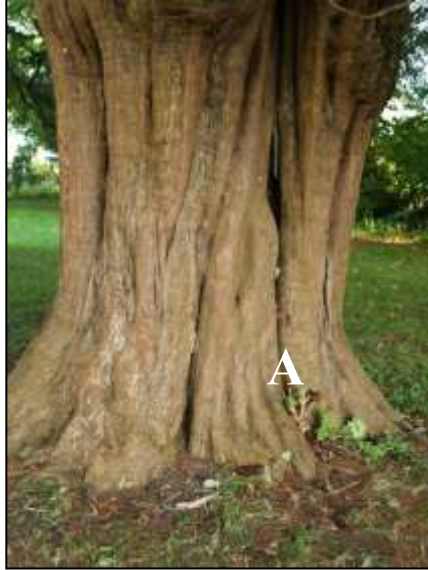
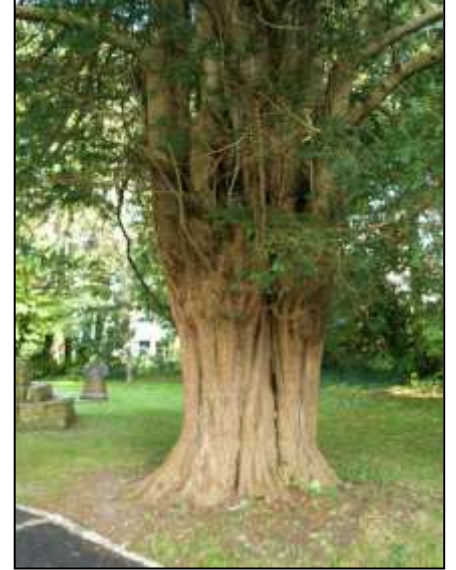
In spite of its small girth, the male yew that grows south of the church is more interesting than it at first seems. While it appears to have a normal cylindrical trunk, closer observation reveals that (A) is internal growth that fills the tree's central space. Around the internal stems are traces of old sapwood as well as crumbling heartwood that fills some of the gap.

On the outside the trunk is devoid of growth for the first 5'. At this height there is considerable bulging caused by branch removal. Above this the branches tend to grow upwards and lateral branches have been systematically removed. Girth was 11' 6" at 2' in 2007.

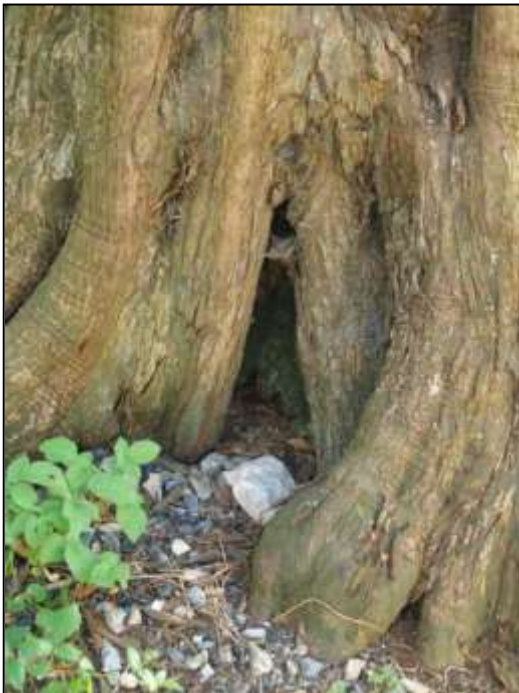
2013: On this visit I also observed a gap about an inch wide on the tree's west side (bottom left) in which could be seen crumbling red heartwood.

Girth had increased by 3" in 6 years to 11' 9" at 2'.
