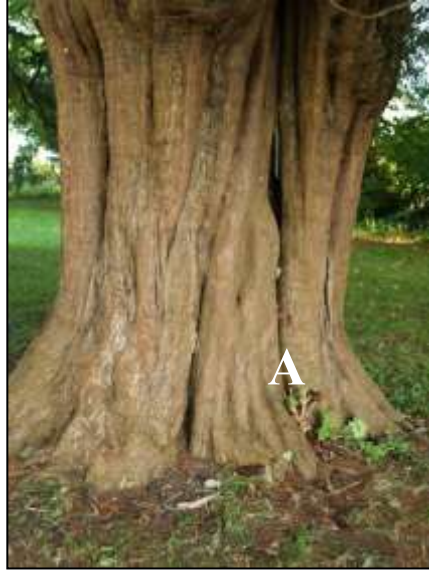
In spite of its small girth, the male yew that grows south of the church is more interesting than it at first seems. While it appears to have a normal cylindrical trunk, closer observation reveals that (A) is internal growth that fills the tree's central space. Around the internal stems are traces of old sapwood as well as crumbling heartwood that fills some of the gap.

On the outside the trunk is devoid of growth for the first 5'. At this height there is considerable bulging caused by branch removal. Above this the branches tend to grow upwards and lateral branches have been systematically removed. Girth was 11' 6" at 2' in 2007.
