A signpost in the car park points towards Cefnlllys Castle. This is also the way to the church, a walk of several hundred yards across fields. The earliest documentary evidence of this church site dates from 1291, but there are indicators that its origins may be in the 10th or 11th century, for example its dedication to St Michael, the circular shape of the churchyard and its boundary marked by old yews.

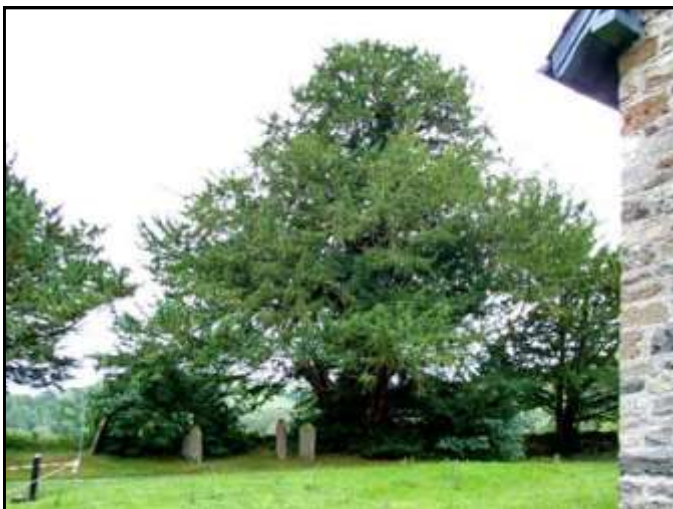
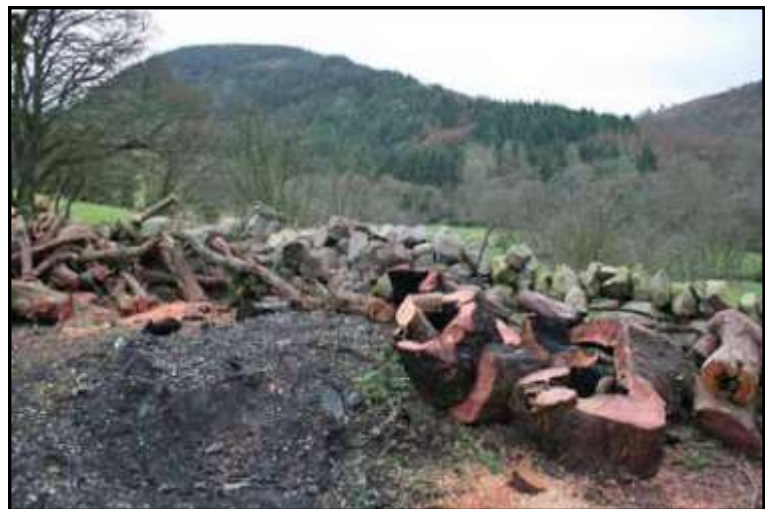
I recorded tree 1 in 1998 as male, with a girth of 16' at 5'. It was photographed by Geoff Garlick in 2006 and a year later by David Alderman after it was burned down.

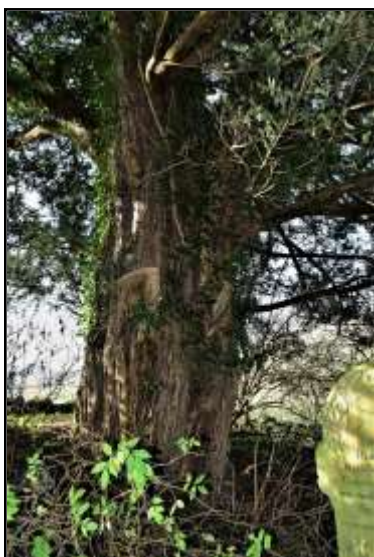
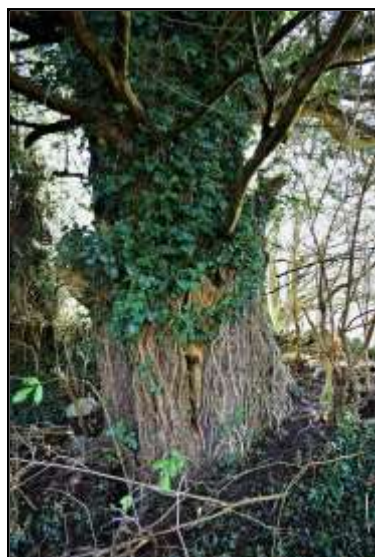
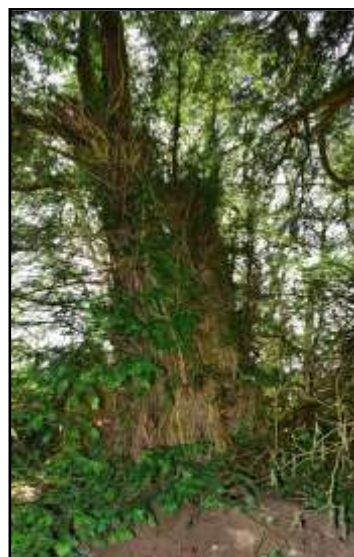
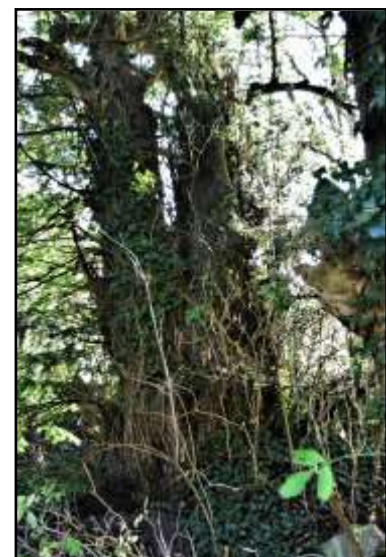
In 1998 I considered trees 2 and 3 to be younger trees and took no further detail. Paul Wood in 2017 makes a case for the two trees possibly having a common origin. Large amounts of dead and dying wood was in evidence, suggesting that here might have been a large tree that has regrown after losing most of its original material. Tree 2 has a thin shell of live wood with much old white sapwood visible all over the bole. This white wood was also sticking out of the bank between yews 2 and 3. Yew 3, again a mixture of living and dying wood, had two leading limbs from a short bole showing signs of stress, with one had broken off under the weight of the dead wood. This tree he thought will become vulnerable in bad weather to toppling over since the did not seem to be enough live wood to anchor it to the ground.

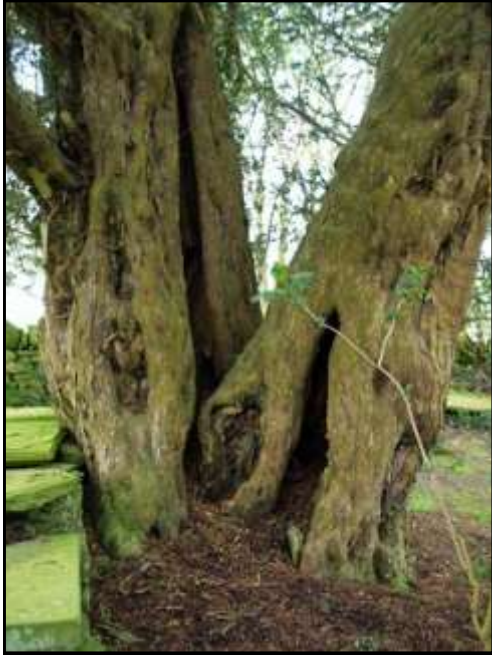
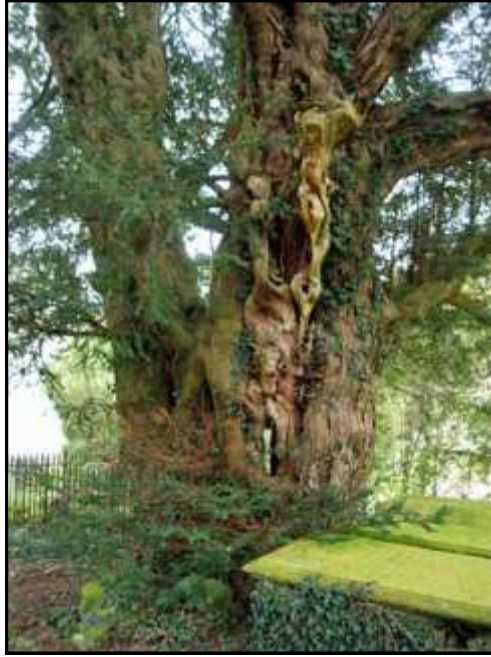
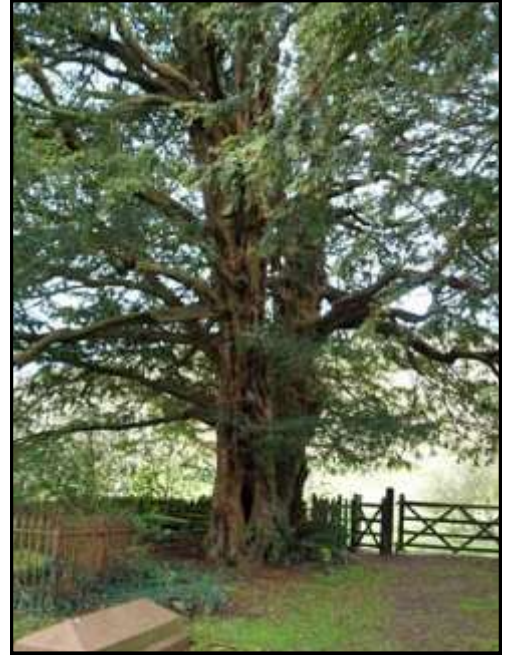
I photographed tree 4 in 2012. It is a distinctive twin trunked yew growing ESE of the church.

Its two stems were recorded as individual trees by the Tree Register in 2007 - with girths of 374 and 302cm at 1.5m. They observed that each trunk was of a similar girth to one of the smaller trees in the churchyard and suggested that they might have been planted originally as separate individual trees.

Experience of looking at hundreds of old yews suggests that this is one tree.

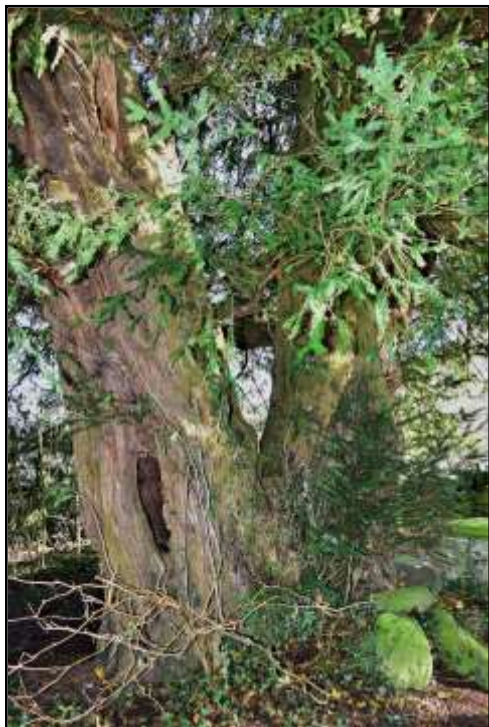
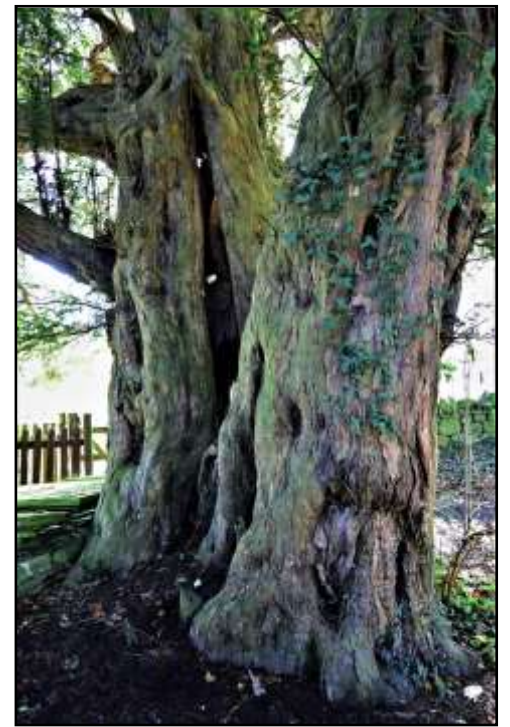
In 2017, when Paul Wood took these photos, the yew appeared in good health with deep green foliage that was plentiful but not thick. A lot of small dead branches had been cut back and protruded from the bole, which was very scaly with many small areas of fungus.

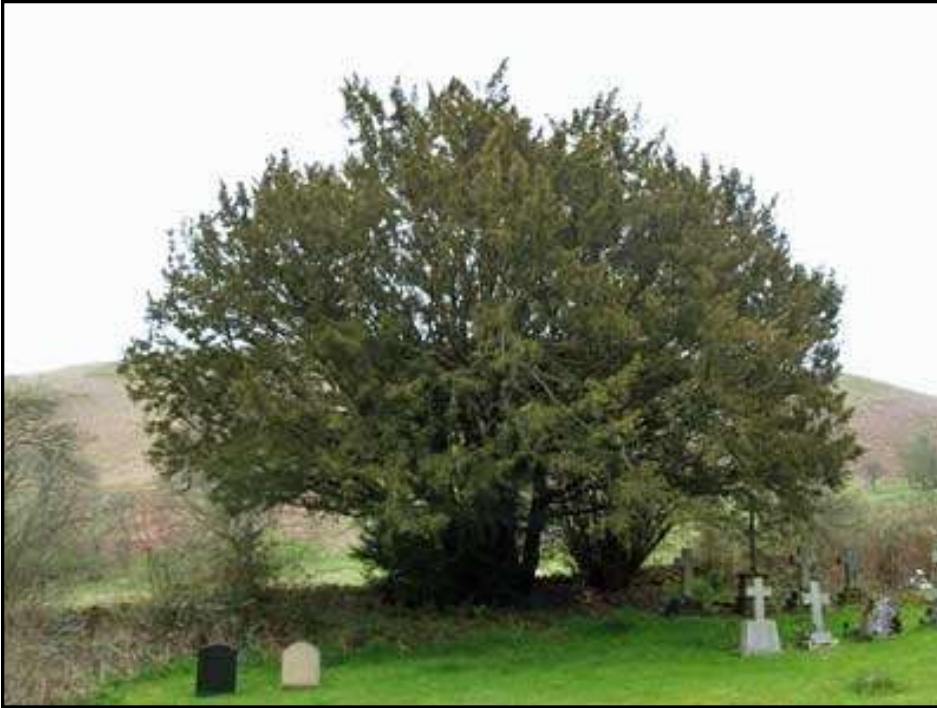
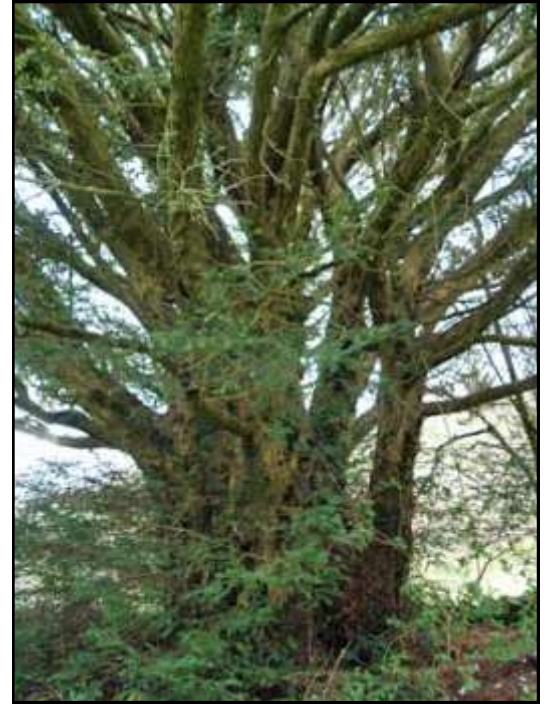
Tree 5 is male. I considered it to be of unhealthy appearance in 1998, but these 2012 photos show renewed vigour. There is a badger sett beneath the tree, and the space was also being used to store composting grasses. Girth in 1998 was approximately 22' at 5'. In September 2005 Russell Cleaver described it as the 'largest girthed yew at this site, multi-stemmed, measured 6.63m (21' 9") at 1.1m. Bushy re-growth, difficult to measure'.

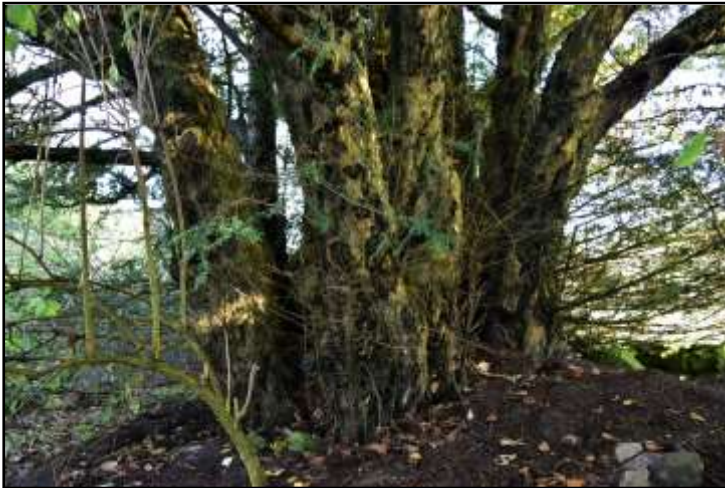
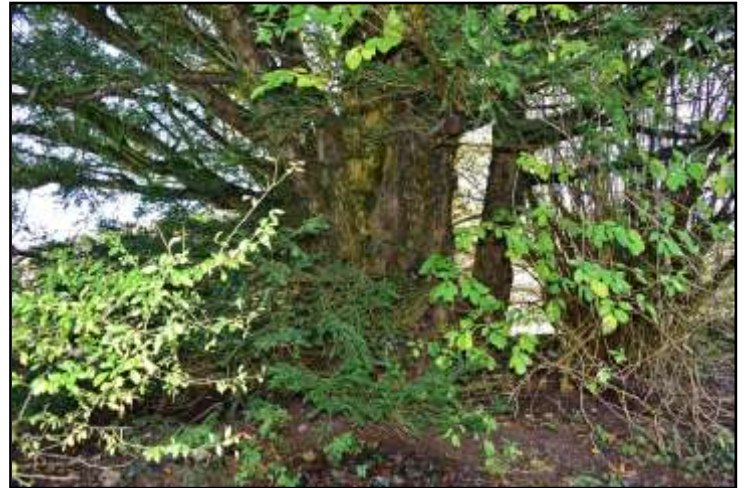
In November 2017 Paul Wood noted that the badger sett was still there, as was the mound of composting grasses and much rubbish. Twiggy growth on low branches meant measurement was impossible. The yew had much healthy looking foliage, but this was not particularly thick. He was unable to get close to the centre of the tree, with only its south side relatively clear.

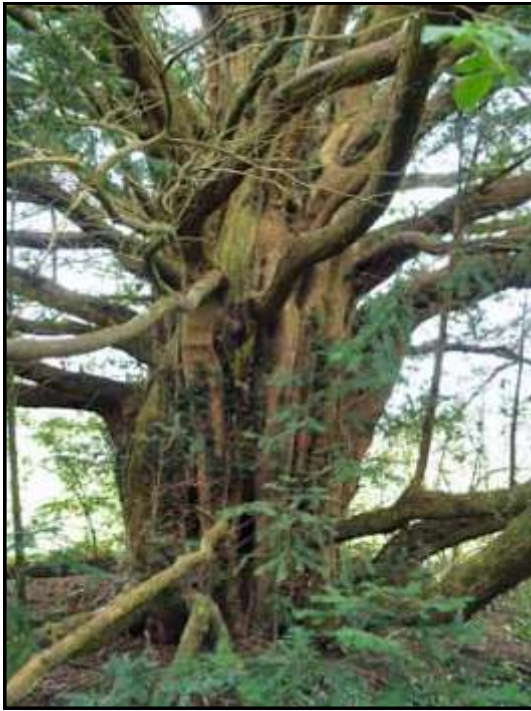
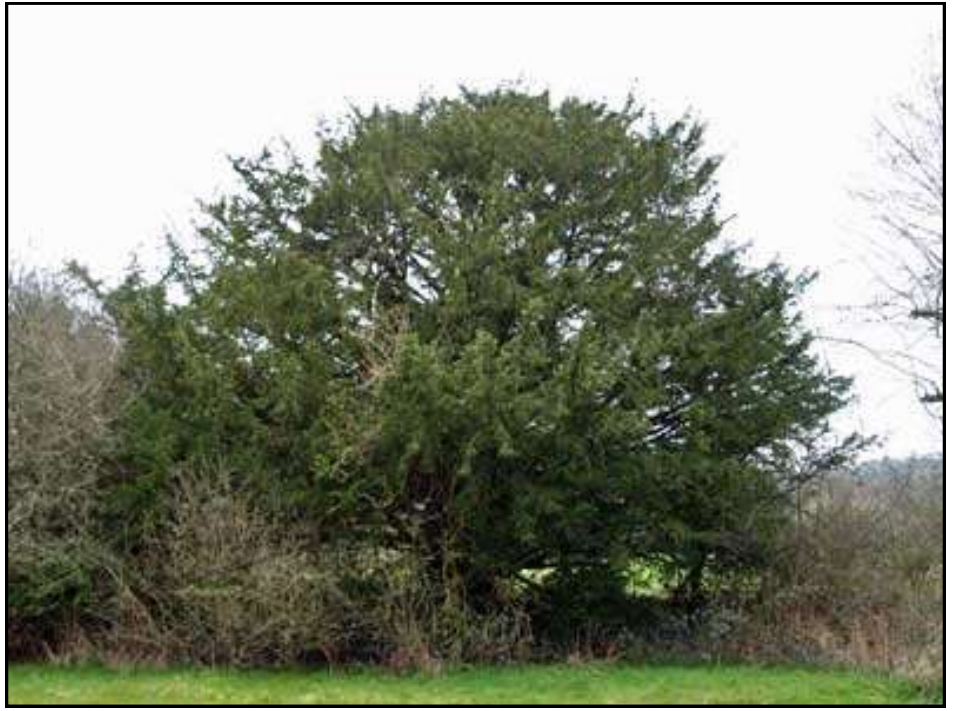
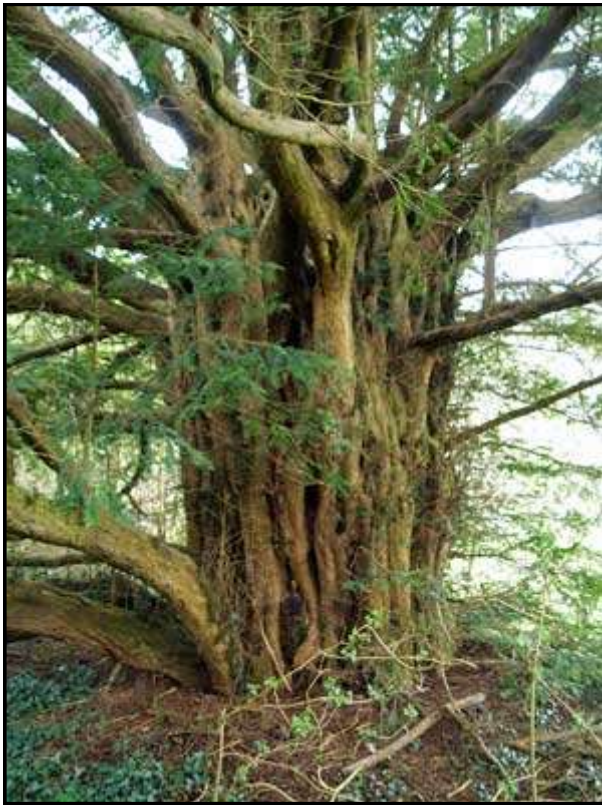
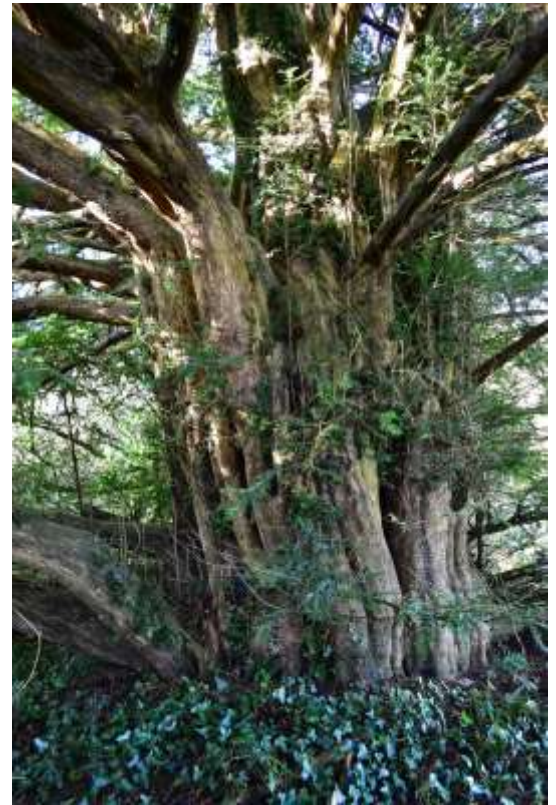
Tree 6 is female with a girth of 18' 4" at 5' in 1998. I photographed the tree in 2012. The photo (bottom right) from Paul wood in 2017 shows the encroachment of ivy.

In September 2005 Russell Cleaver described an 'open grown canopy, short, squat bole, branches feathered to the ground. Girth 5.29m (17' 4") at 0.65m.

November 2017: Paul Wood described the yew as difficult to approach with low branches resting on the ground. Of the three veterans in the churchyard, he considered this female to be the healthiest. The bole was reached through brambles and ivy, which surrounded this yew and was beginning to grow into the tree. Many established limbs at ground level were noted on its south side but none on the north side, where they have been removed, presumably to avoid them hanging over into the field where cattle were grazing. No hollowing was noted.

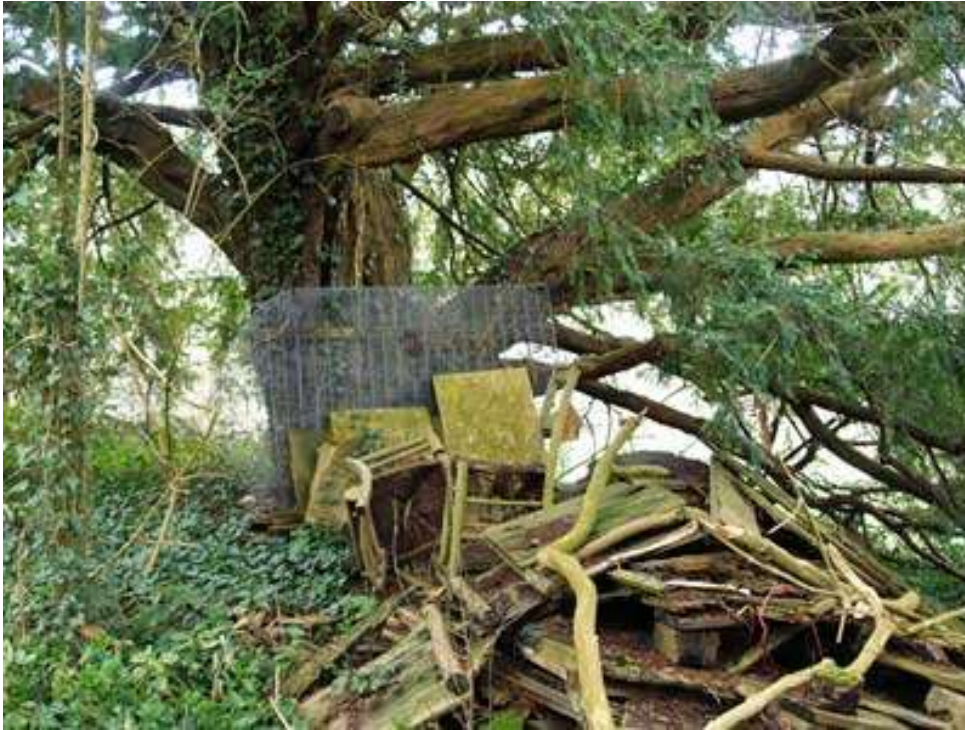
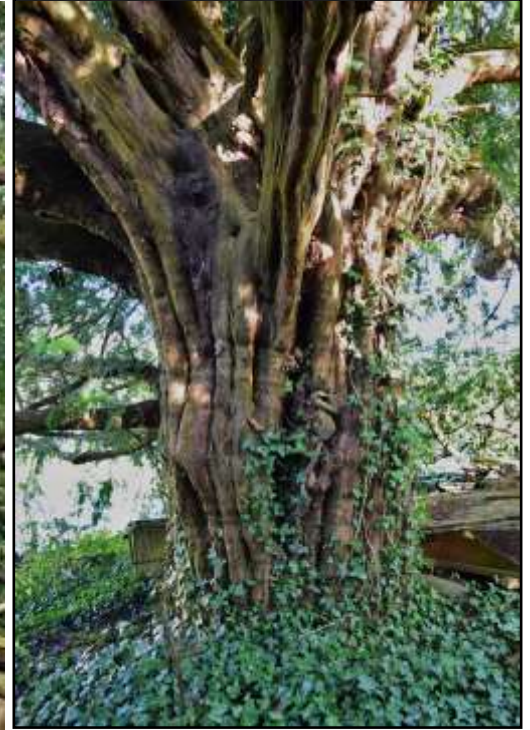
Tree 7 on the plan grows north of the church. It illustrates poor management in a churchyard where a veteran has already burned down. This churchyard seems to be much visited at night, with night lights placed in some of the branches. It seems only a matter of time before another tree is lost.

Though of relatively small girth, a large hollowed out branch rises from the centre, suggesting a hollow bole. In 2012 (left) the area was being used to store chairs and other wood. Since it was fire that destroyed a veteran here some years earlier the church warden was advised to remove this bonfire material. The other photos were taken by Paul Wood in 2017 who wrote the following description:

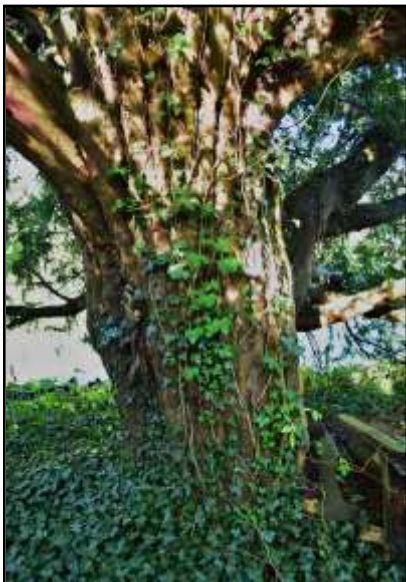
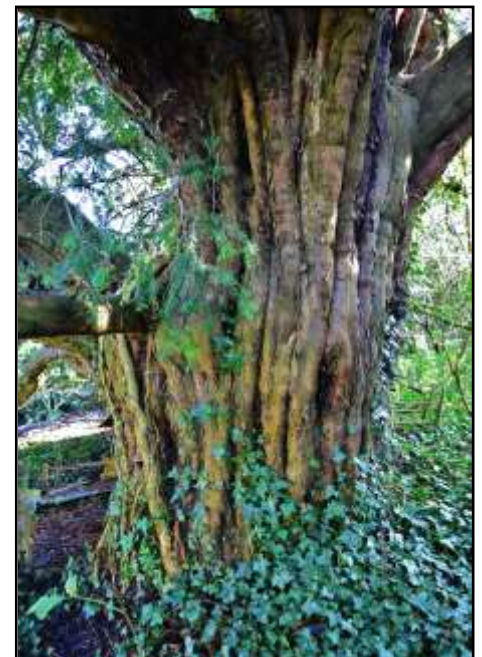
Old furniture and rubbish are still to be found on its eastern side. Its western side was inaccessible because of overgrown elder and brambles while the southern side was blocked by a mound of grass, rotten wood, brambles and general rubbish. BUT - we forced a path through and found a tree in surprisingly good condition. All the trees at Cefynllys have varying amounts of lichen but this one was plastered with it. The bole is well fluted and a gap has now opened on the south side at ground level and shows that it is beginning to hollow. Many small branches have been removed from various points on a bole which is quite scaly in appearance and was purplish/reddish at the time of the visit. The tree is quite squat and appeared to have suffered a little storm damage at about 12'/15' up on its south side. A small amount of ivy was beginning to climb into it.

Girth was recorded as 12' 0" (366cm) at 1' and 12' 8" (386cm) at 2'.
