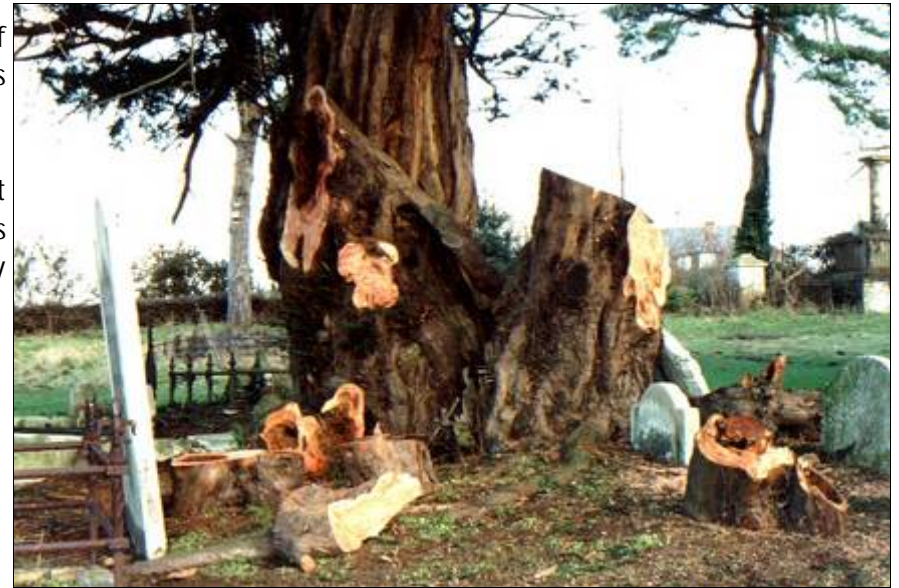
2001: The yew, growing WSW of the church, was originally a tree of two stems from a low bole, with a 3rd section growing outwards rather than upwards between the two.

The tree was damaged in the storm of 1987, although this was not the reason for the destruction of two of its three sections. This, I was told, was necessary because some of their branches hung over nearby graves and this had led to complaints.

Girth of this tree was 17' 3" at 1'.
