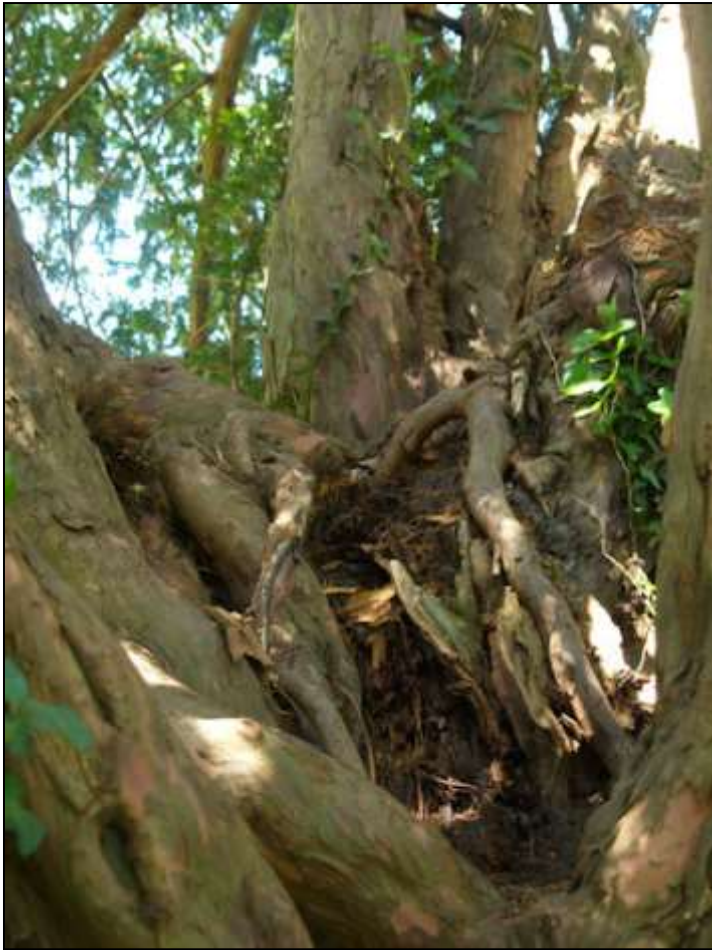
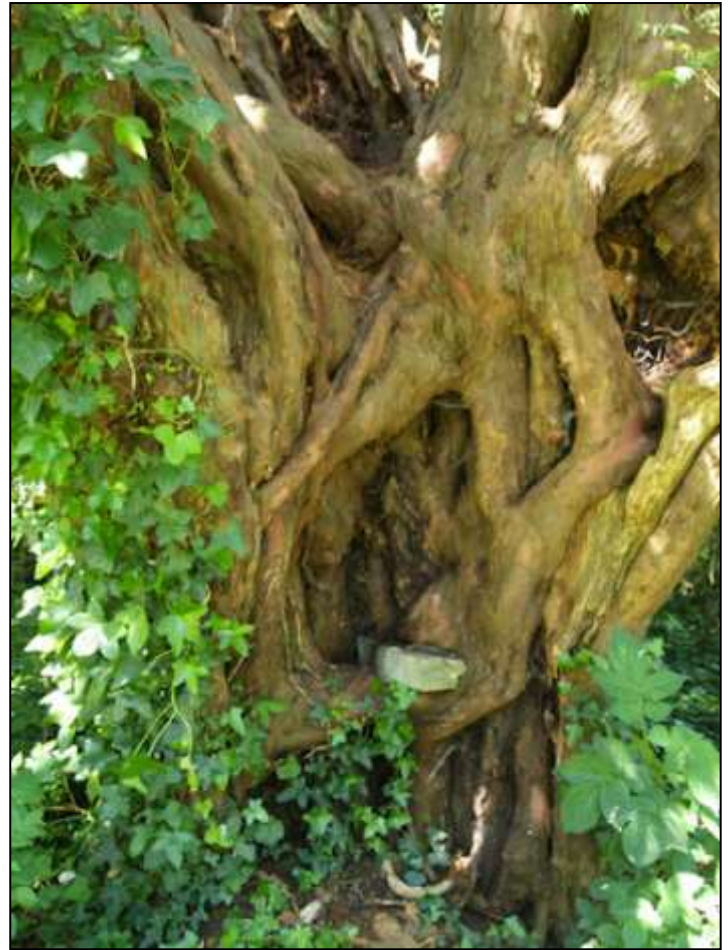
This vigorous and healthy male yew grows NW of church. Girth was above 12', but the tree has been larger. It appears to have been pollarded at about 6', creating a platform around the edges of which now grow many thick upright branches. From many of these, roots have formed which now grow downwards into the decaying heartwood.

On the west side of the tree branches dip close to the ground, while the east face is completely open. In the centre of the tree is a jumble of internal stems, as well as a large stone that has been swallowed up as new wood is laid down.

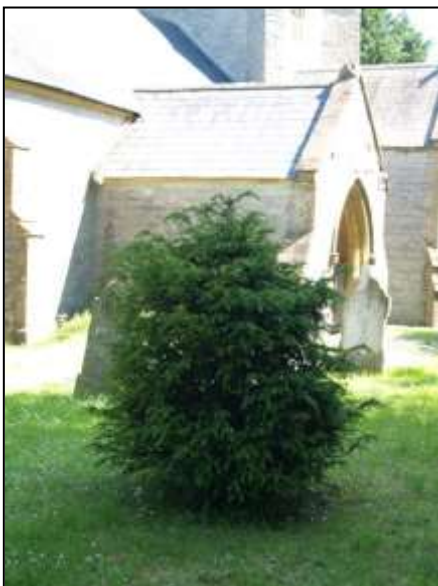
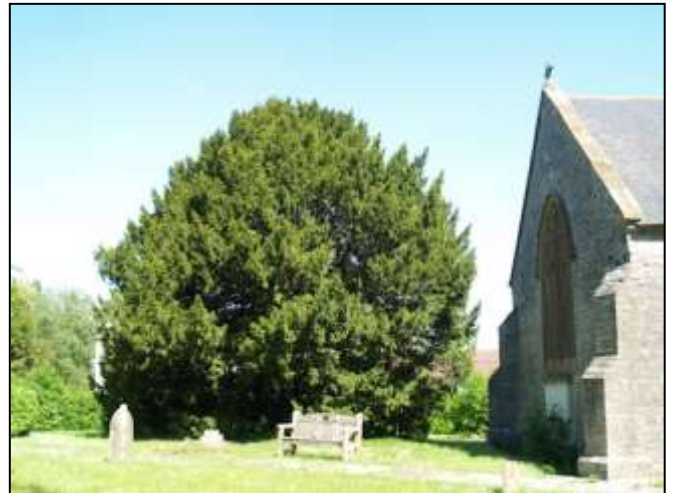
Also on the south side and to the west of the 2<sup>nd</sup> tree is this millennium yew, a replacement for their original millennium tree that had been vandalised.
