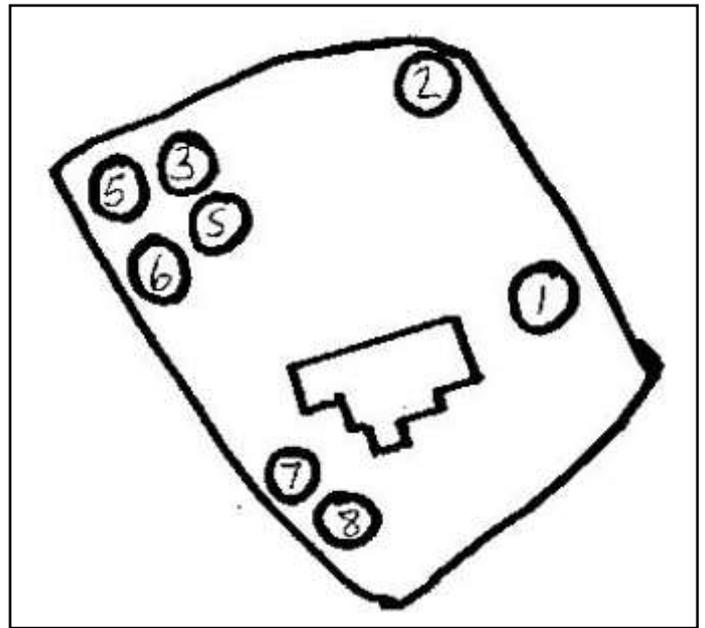
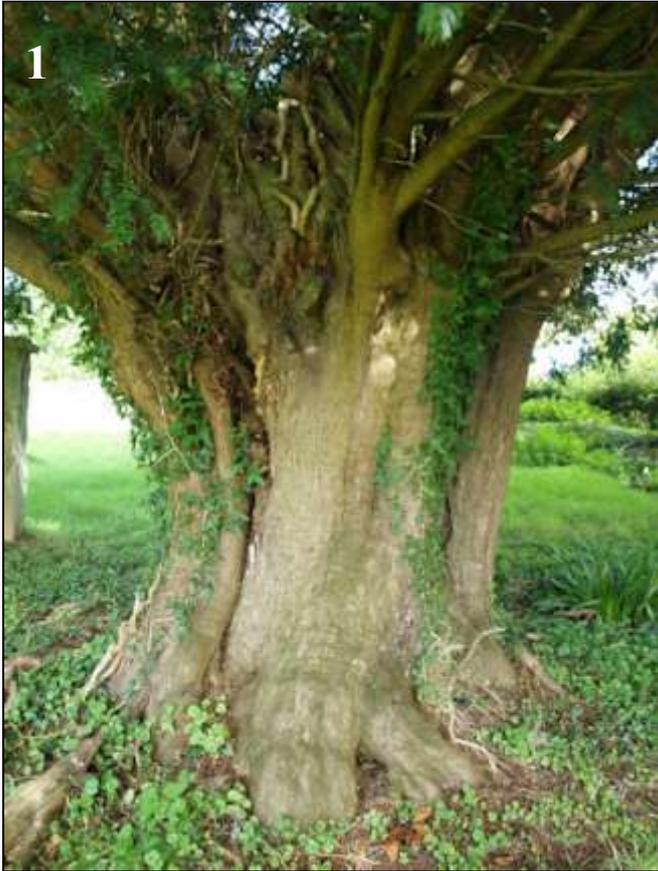
Eight yews are recorded here. The veteran (1) grows due east of the church. It appears to have been topped at a height of about 8' long ago and now has much regrowth on the edges of the old trunk at this height. Beneath this height the trunk is hollow or hollowing with red/brown cubical rot clearly seen within. It was measured at 1' 6" above the higher ground (to avoid the bulging root on the south side) and a girth of 12' 9" was recorded.

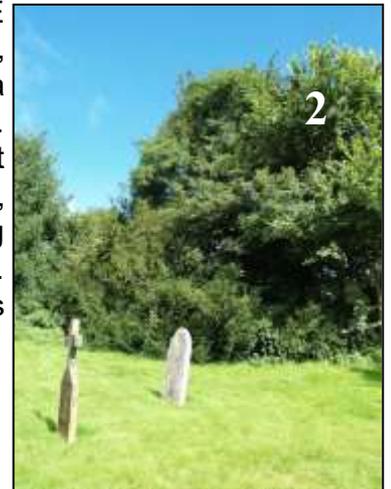
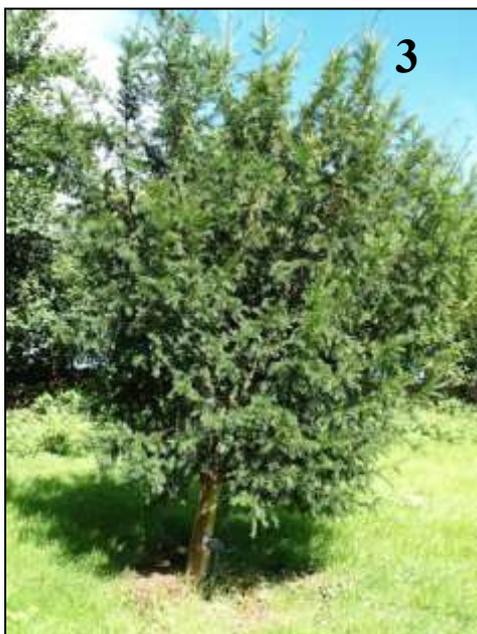
Yew 2, growing at the NE perimeter of the churchyard, appears from a distance to be a large number of young yews. Closer inspection shows that they are branches of a large, well hidden male tree, growing above a drop to the road below. Girth of this yew was perhaps between 10' and 12'.

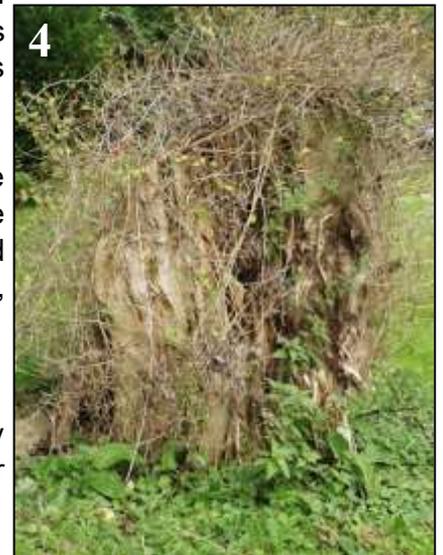
Yew 4, just to the south of the millennium yew, is this large stump. The sapwood is well rotted so it appears to have been dead for a long time. It was only by finding sections of bark that I was able to confirm it as yew. It appears to have been a tree with hollow sections and its stump was in at least 3 parts.
