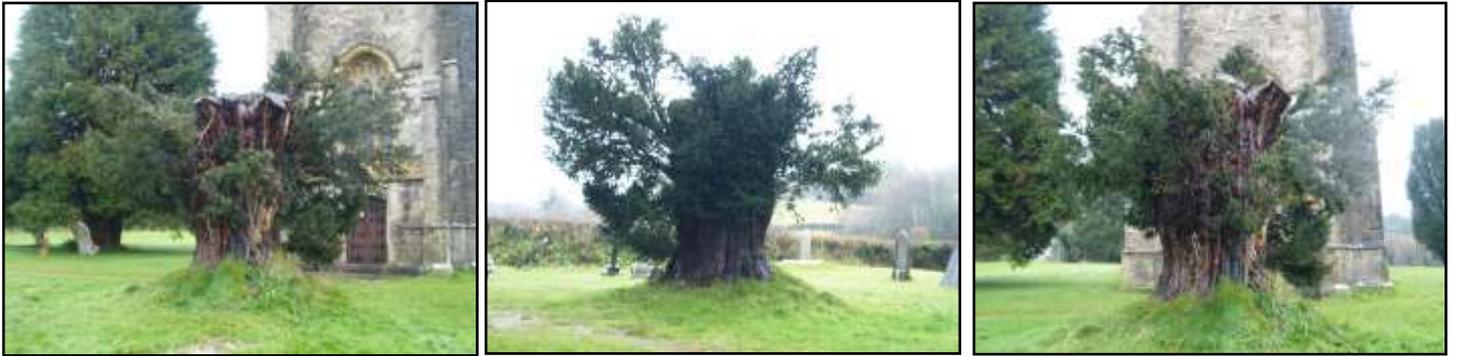
In 2000 I recorded a yew, WSW of the church, that had a fine looking trunk with some fluting, and a girth of 13' 8" at 2'. There was some bulging at 3' caused by branch removal and also twiggy growth at this height. Above a height of 8' were numerous branches. Unfortunately no photos were taken. When I returned in 2011, it was to find that all of the tree's major branches had been removed, as seen below.

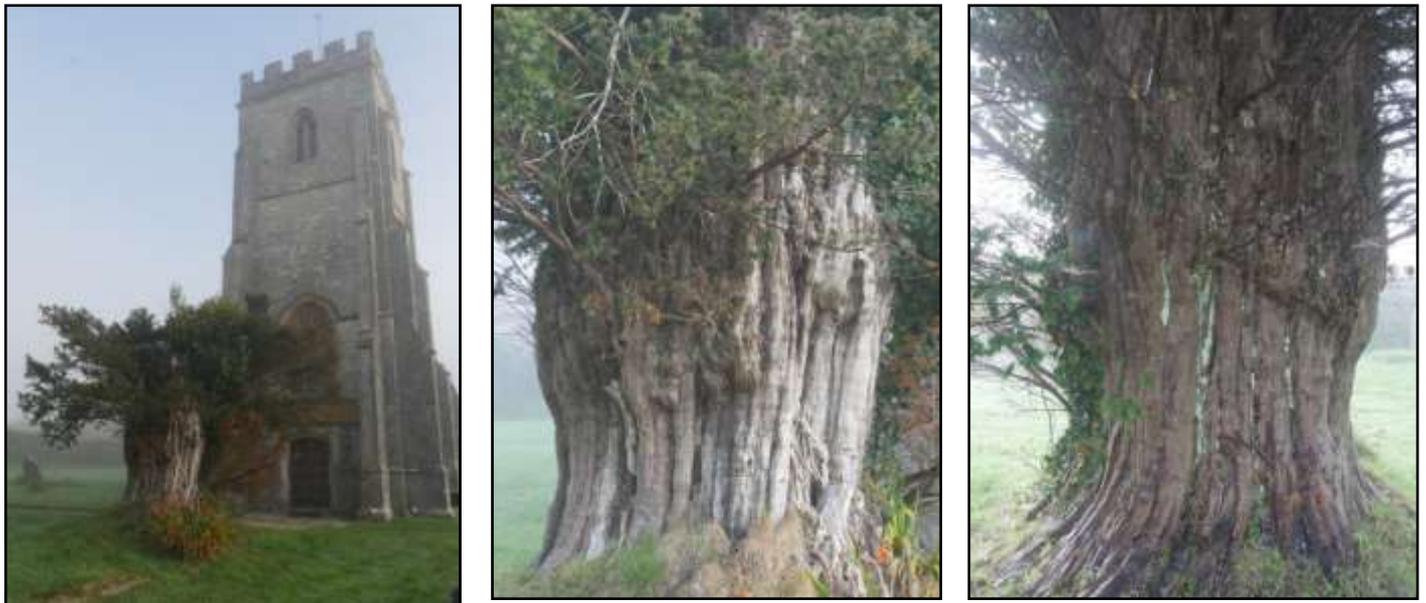
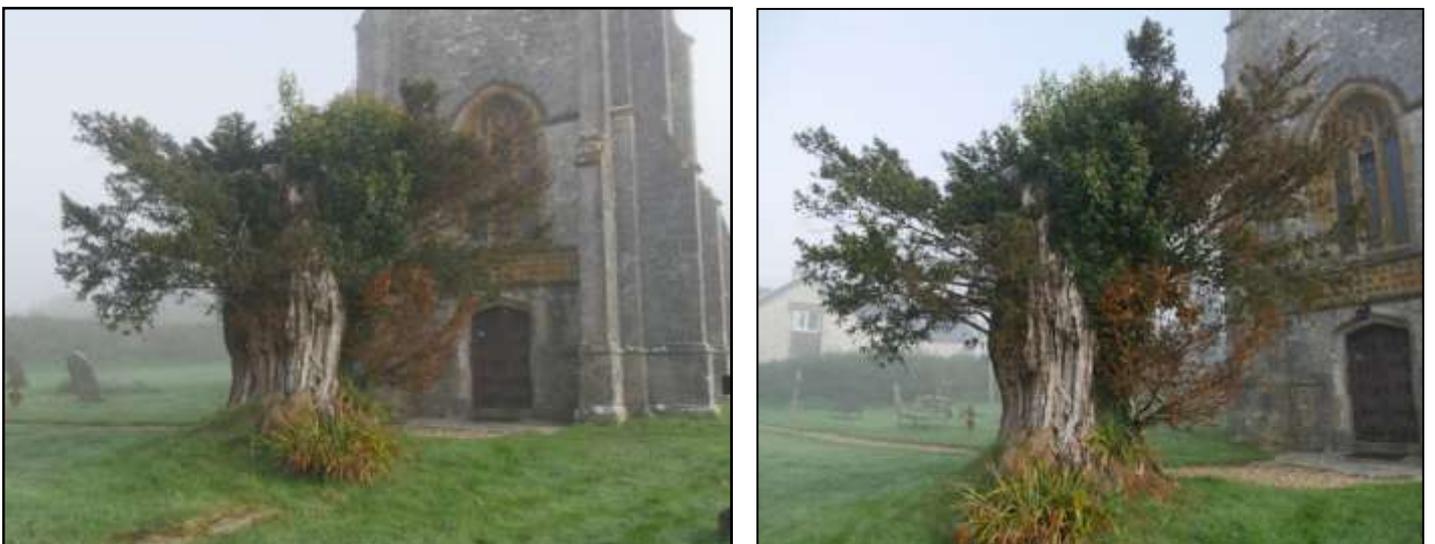
I returned on a foggy day in 2016 and the tree continues to recovery. More of its twiggy branches were alive than dead, with green foliage on the west side, while on the south side foliage was a more rusty green/brown colour. Some new growth was springing from the trunk on the north side. Girth still 13' 8" at 2'.
