*Newlands Corner  
and  
Merrow Downs*

*A survey of the yews*

Peter Norton August 2012

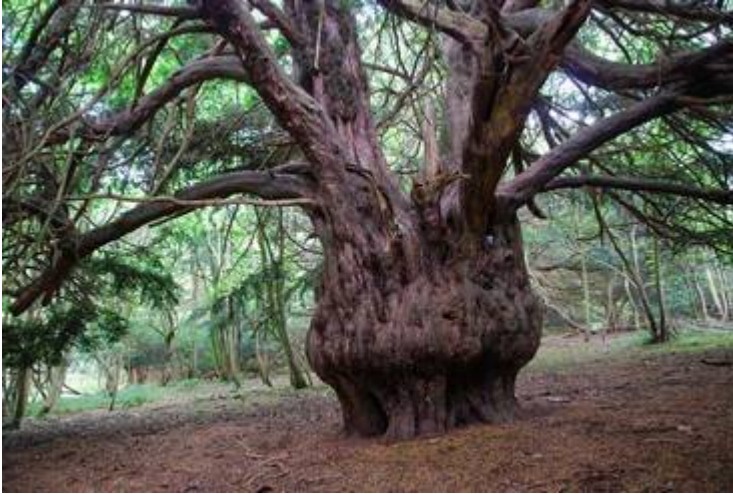
Tree Ident	Grid Loc	Area	Sex	Girth			Height measured	Comments
				Ft	Ins	Mtrs		
8	<a href="#">TQ0413149530</a>	Newlands	Male	16	8	5.080	1'	2 leaders from a 5' break of crown. Major layering evident. 1 embedded nail
12	<a href="#">TQ0410449596</a>	Newlands	Male	15	7	4.750	Root crown	Large cavity, internal growth, hollowing branches, major layer though host branch has withered
13	<a href="#">TQ0408649609</a>	Newlands	Male	14	9	4.496	Root crown	Hollow but no internal stem
14	<a href="#">TQ0407849595</a>	Newlands	Female	10	9	3.277	Root crown	Loss of outer shell
15	<a href="#">TQ0406549593</a>	Newlands	Female	22	4	6.807	2'	Hollow and fragmented, many seedlings, 3 embedded nails
16	<a href="#">TQ0407349560</a>	Newlands	Female	15	5	4.699	1'	7' break of crown
18	<a href="#">TQ0403849605</a>	Newlands	Male	18	6	5.639	Root crown	Very sparse foliage, 2 embedded nails
21	<a href="#">TQ0403249592</a>	Newlands	Male	14	4	4.369	Root crown	Loss of outer shell, internal growth.

TQ0403249592 M 14' 4" at root crown  
Urn shaped with loss of outer shell, small internal growth

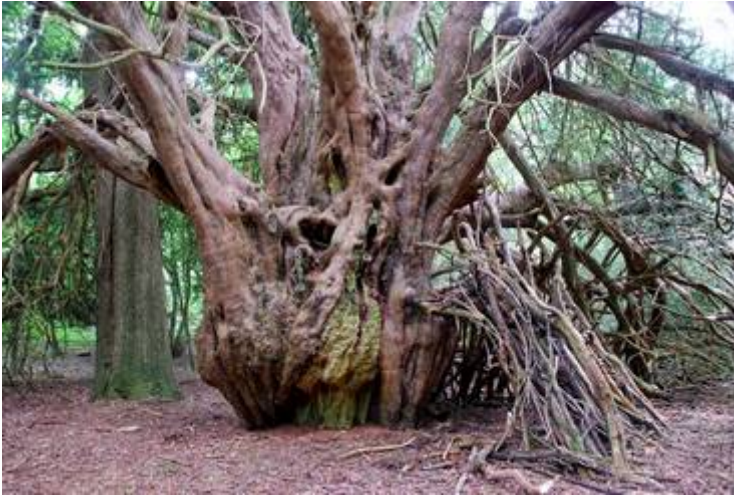
TQ0398749603 M 16' 8" at ground  
Hollowing branches from a 5' break of crown

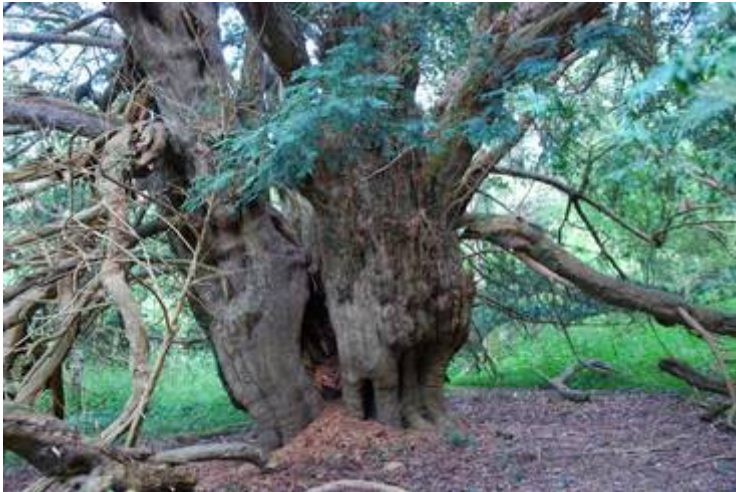
TQ0423850022 F 15' 2" at root crown  
Hollowing

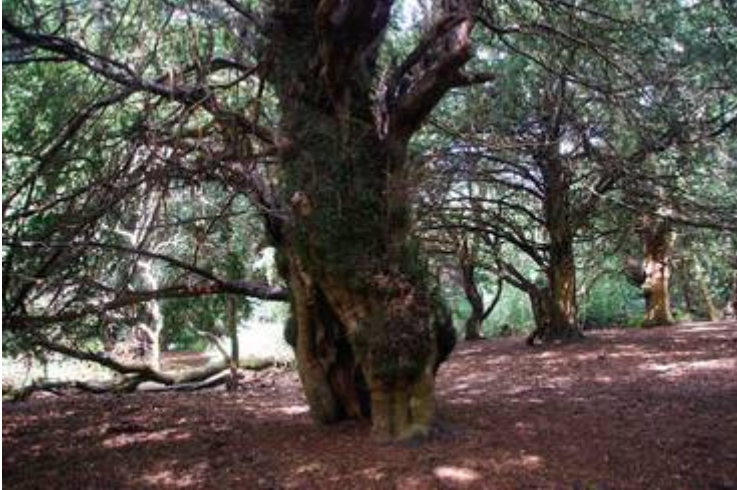
TQ0340849202 F 11' 11" at root crown  
Hollow, major loss of outer shell, no internal stem

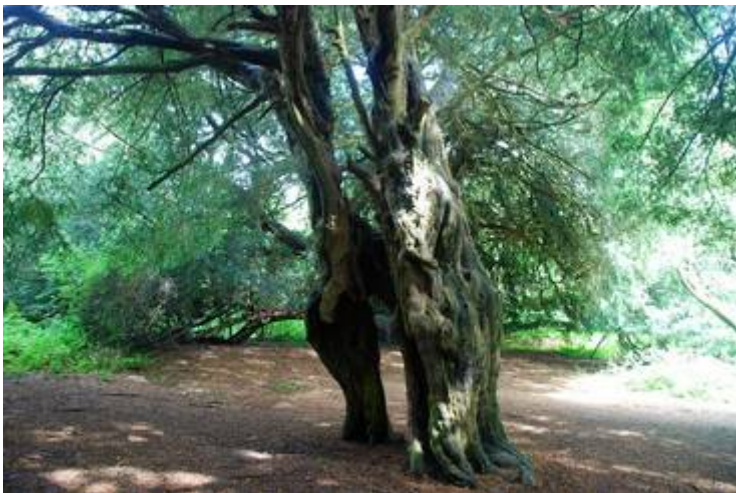
TQ0325649138 M 12' 6" at root crown  
3 segments, hollow, close to the west car park
