*Newlands Corner  
and  
Merrow Downs*

*A survey of the yews*

Peter Norton August 2012

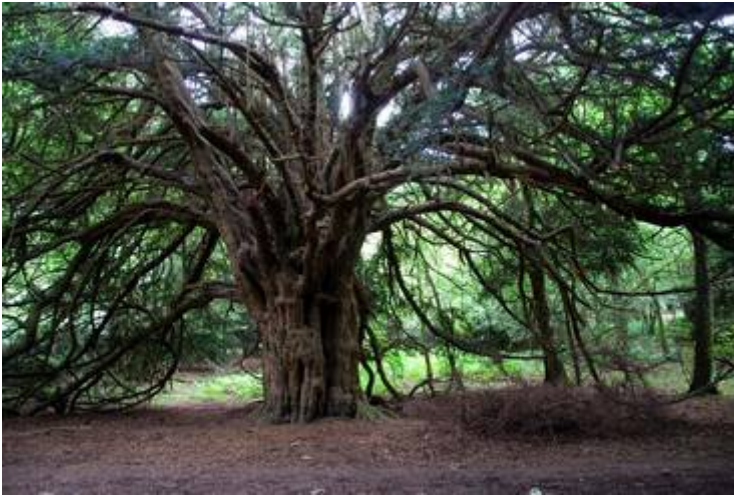
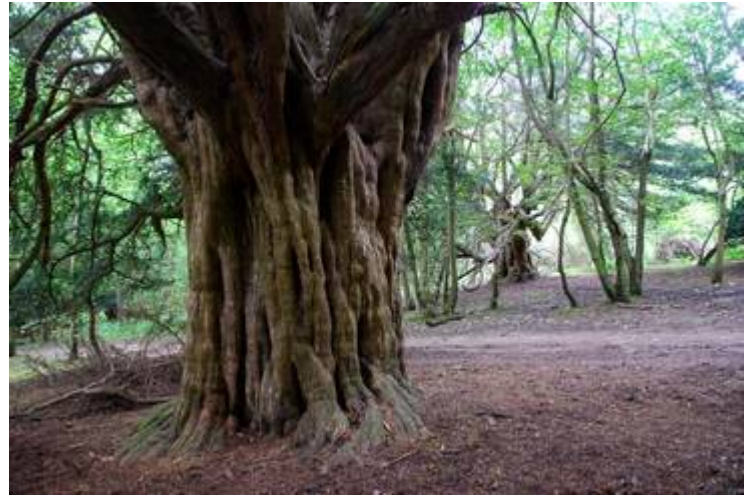
TQ0407349560

15' 5" at 1' with a 7' break of crown

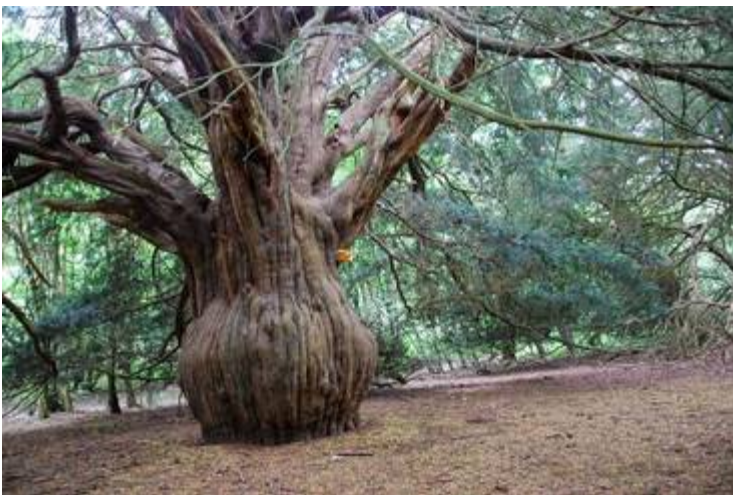
22	<a href="#">TQ0399049562</a>	Newlands	Male	19	9	6.020	Root crown	Possibly hollow, 3 embedded nails
23	<a href="#">TQ0398749603</a>	Newlands	Male	16	8	5.080	Root crown	5' break of crown, hollowing branches
24	<a href="#">TQ0396849615</a>	Newlands	Male	17	1	5.207	6"	Hollow but no internal stem
27	<a href="#">TQ0401949627</a>	Newlands	Male	14	11	4.547	1'	was this one tree and fragmented into 3 although 2 are one tree 9' 3" the second was 7' 6". Girth around all recorded 14' 11" at 1'
28	<a href="#">TQ0400749624</a>	Newlands	Female	15		4.572	1'	Sparse foliage, Cavities in the upper bole, tree close by dead
29	<a href="#">TQ0401549617</a>	Newlands	?	16	2	4.928	1'	Possibly dead, no foliage, unable to determin sex
30	<a href="#">TQ0401949633</a>	Newlands	Female	17	11	5.461	Root crown	Hollow, internal stems, many seedlings. 2nd visit revealed a whitebeam growing from the canopy with roots having reached the ground through the bole of the yew

TQ0399049562 M 19' 9" at root crown  
Possibly hollow, sparse foliage and again note the cut branch and the flow of new wood in the third photograph

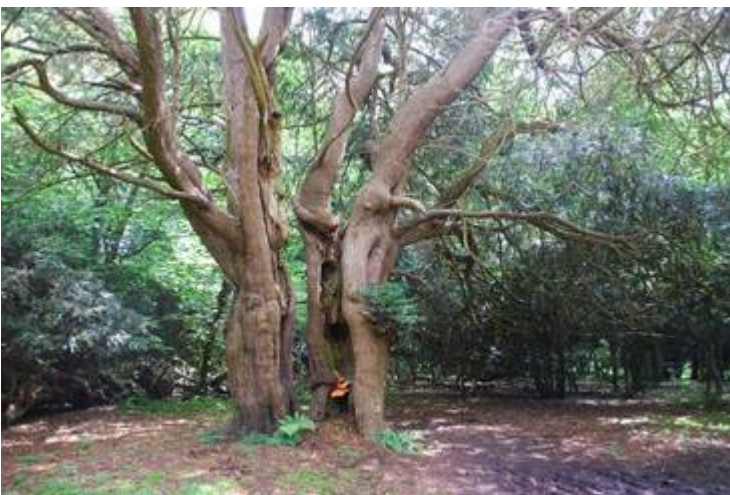
TQ0401949627 M 14' 11" at 1'  
Fragmented in 3 sections

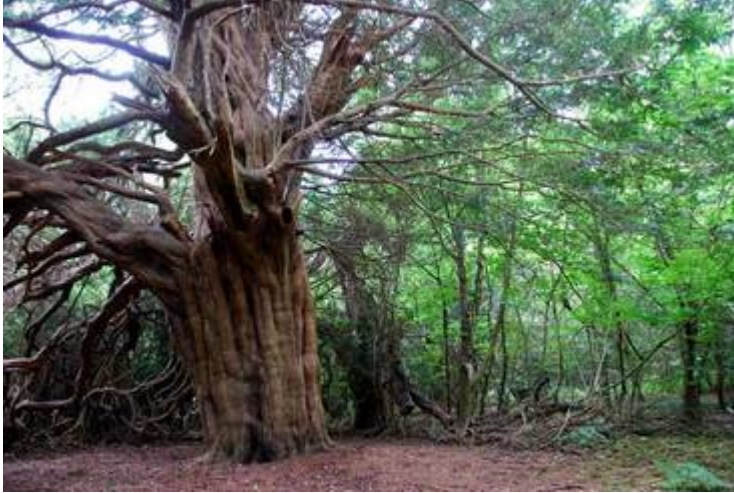
TQ0400749624 F 15' at 1'  
Sparse foliage, cavities in the upper bole

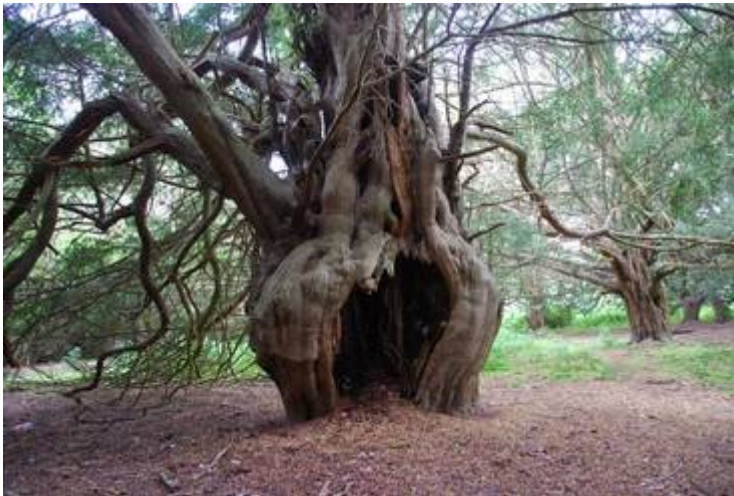
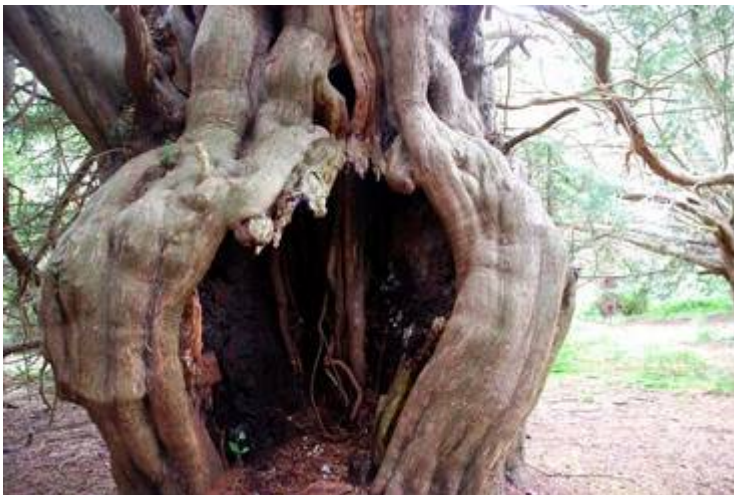
TQ0401949633 F 17' 11" at root crown  
Hollow, internal stems, many seedlings. Whitebeam grows from the canopy on the main leader with roots having reached the ground through the bole of the yew. Third photograph shows the yew roots on the right while those on the left are from the whitebeam. Fourth photograph indicates a cut branch being covered with new wood.

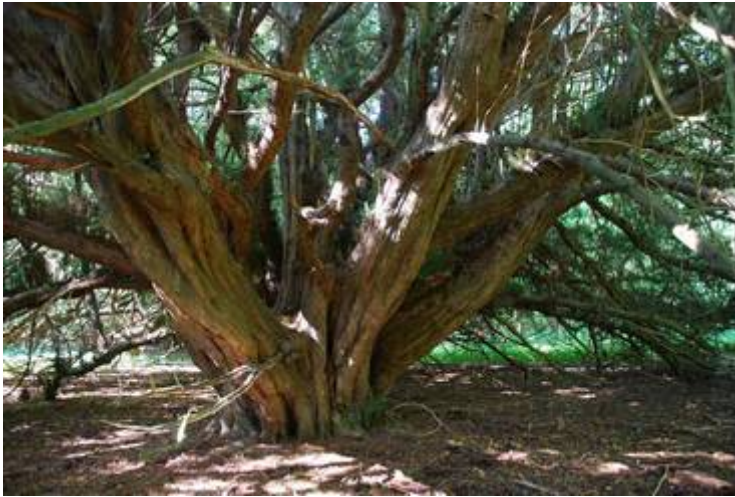
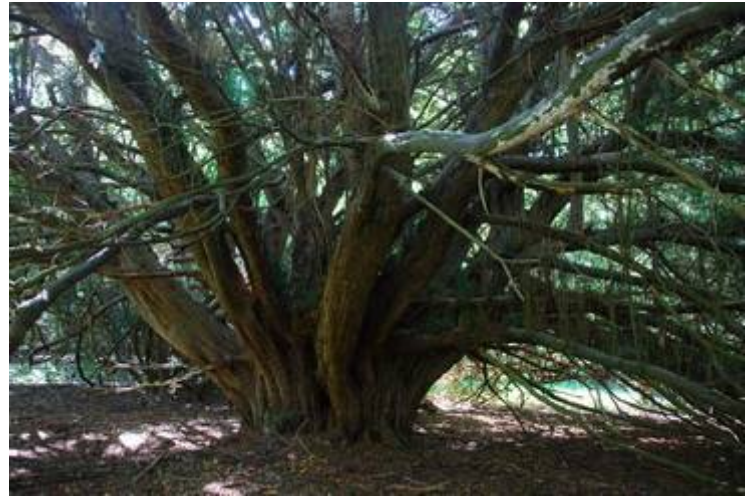
TQ0384349616 M 17' 11" at root crown

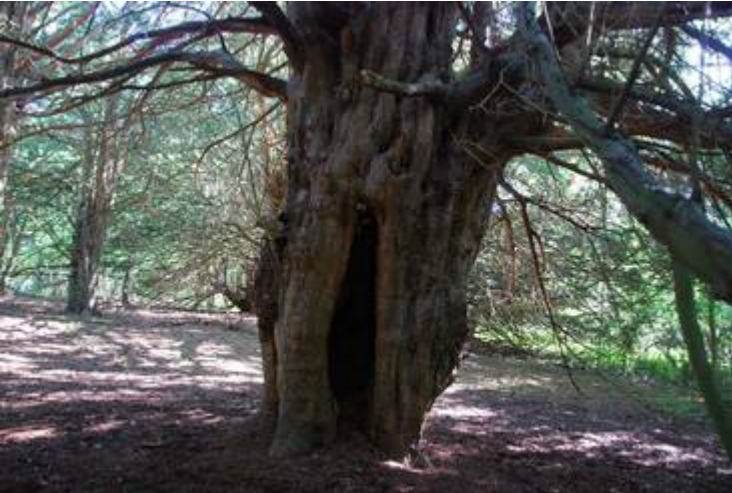
TQ0374149632 F 12' 5" at root crown  
Hollow with small internal stem

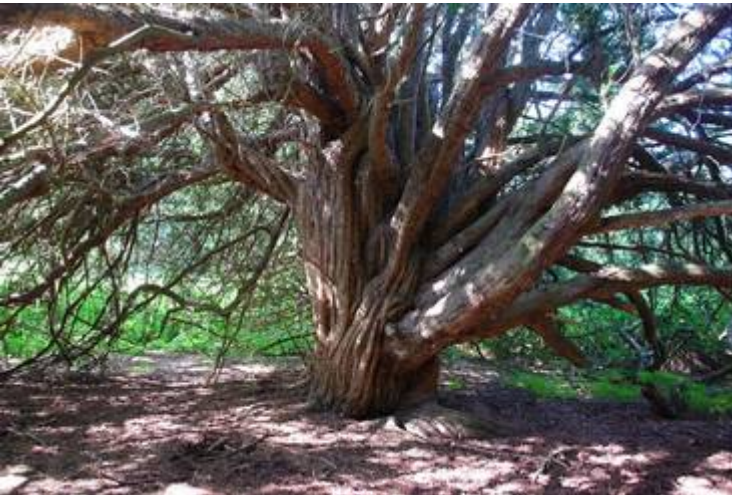
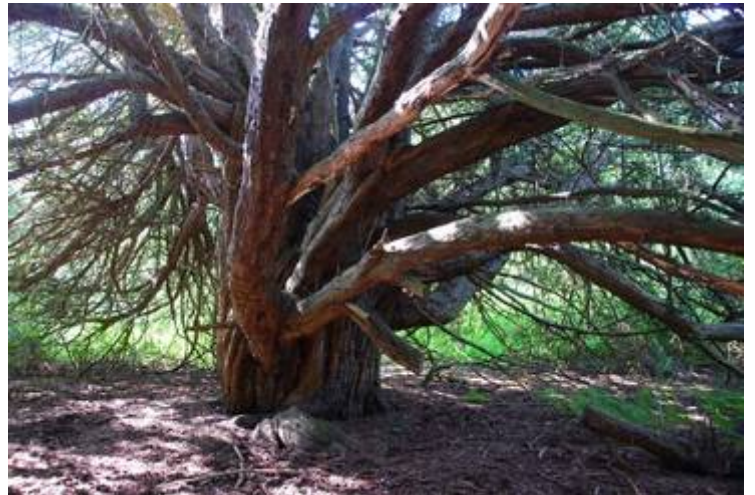
TQ0367249574 M 14' 1" at root crown

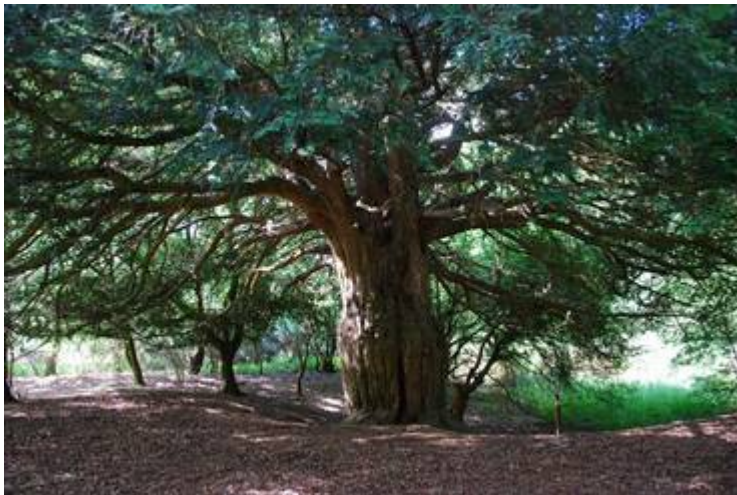
TQ0365449822 F 13' 8" at root crown, hollow

58	<a href="#">TQ0365449822</a>	Newlands	Female	13	8	4.166	Root crown	This hollow yew is found just west of the footpath before crossing the minor road
Lost the footpath near the trig point, so first yews recorded are further away, returned along the foot path much later								
59	<a href="#">TQ0425649900</a>	Merrow	Male	19	1	5.817	Root crown	8' break of crown, hollowing (rotting stem at the break of crown - may be the whitebeam)
60	<a href="#">TQ0423749890</a>	Merrow	Female	13	1	3.988	Root crown	Very sparse foliage, fragmenting, hollow
61	<a href="#">TQ0424949923</a>	Merrow	Male	20	10	6.350	2'	2 halves, hollow, no sign of internal growth, also recorded 21' 5" at root crown
62	<a href="#">TQ0420749933</a>	Merrow	Male	17		5.182	2'	Loss of major branch, fragmenting, some foliage
63	<a href="#">TQ0420949930</a>	Merrow	Male	14	4	4.369	Root crown	Hollowing
64	<a href="#">TQ0425249948</a>	Merrow	Male	20	2	6.147	Root crown	Missed on previous visit, Large internal root

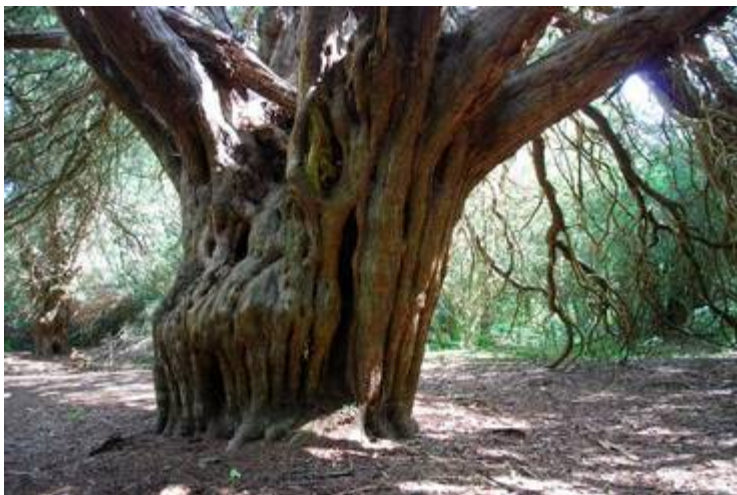
TQ0425649900 M 19' 1" at root crown  
Hollowing, having an 8' break of crown along with sparse foliage

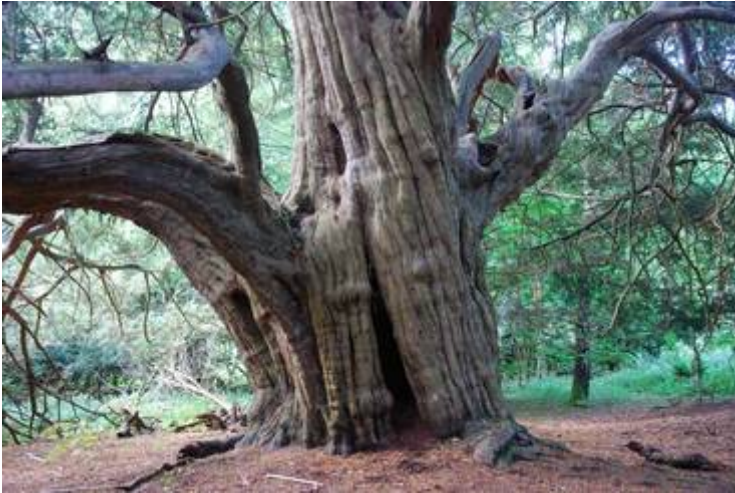
61	<a href="#">TQ0424949923</a>	Merrow	Male	20	10	6.350	2'	2 halves, hollow, no sign of internal growth, also recorded 21' 5" at root crown
62	<a href="#">TQ0420749933</a>	Merrow	Male	17		5.182	2'	Loss of major branch, fragmenting, some foliage
63	<a href="#">TQ0420949930</a>	Merrow	Male	14	4	4.369	Root crown	Hollowing
64	<a href="#">TQ0425249948</a>	Merrow	Male	20	2	6.147	Root crown	Missed on previous visit, Large internal root
68	<a href="#">TQ0425649942</a>	Merrow	Female	14	2	4.318	Root crown	Many lost branches
69	<a href="#">TQ0418649937</a>	Merrow	Male	16	6	5.029	Root crown	12' break of crown, 4 leaders, hollowing, fragmenting
70	<a href="#">TQ0421449971</a>	Merrow	Male	20		6.096	6"	Sparse foliage,
72	<a href="#">TQ0423349996</a>	Merrow	Female	15	3	4.648	Root crown	hollowing, fragmented, sparse foliage
75	<a href="#">TQ0424150002</a>	Merrow	Female	10	9	3.277	Root crown	Hollowing, internal stem

TQ0424949923 M 20' 10" at 2'  
Splitting into two halves, hollow, no sign of internal growth, also recorded 21' 5" at root crown

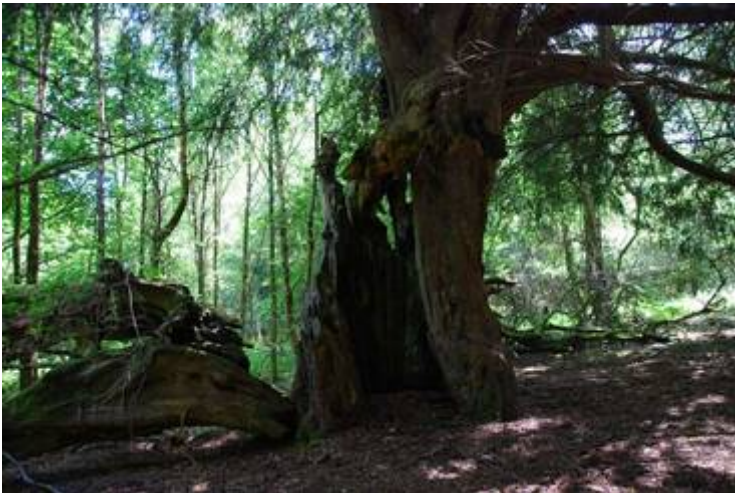
TQ0420749933 M 17' at 2'  
Loss of major branch, fragmenting, some foliage

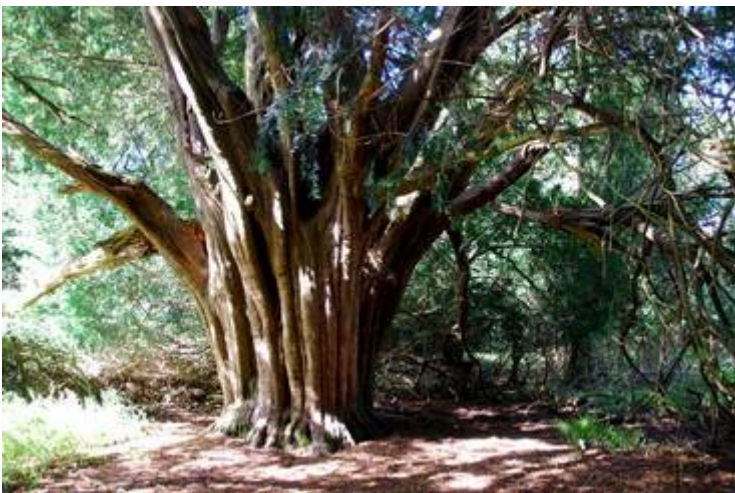
TQ0425249948 M 20' 2" at root crown  
Large internal stem

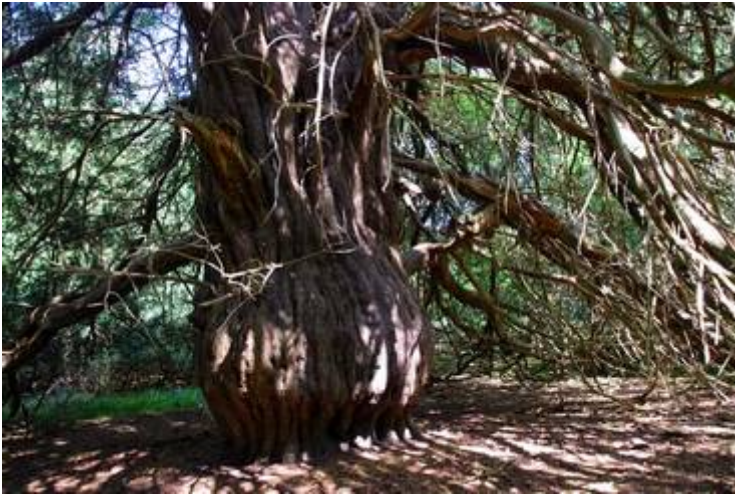
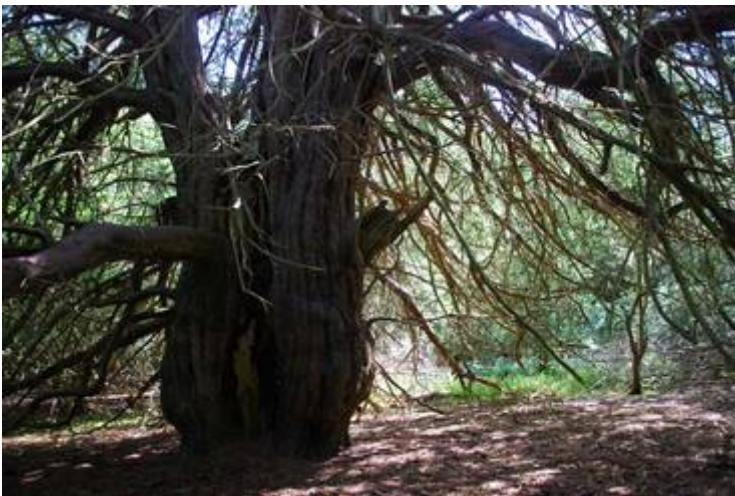
TQ0418649937 M 16' 6" at root crown  
12' break of crown, 4 leaders, hollowing, fragmenting, also note the cut branch and flow of new wood

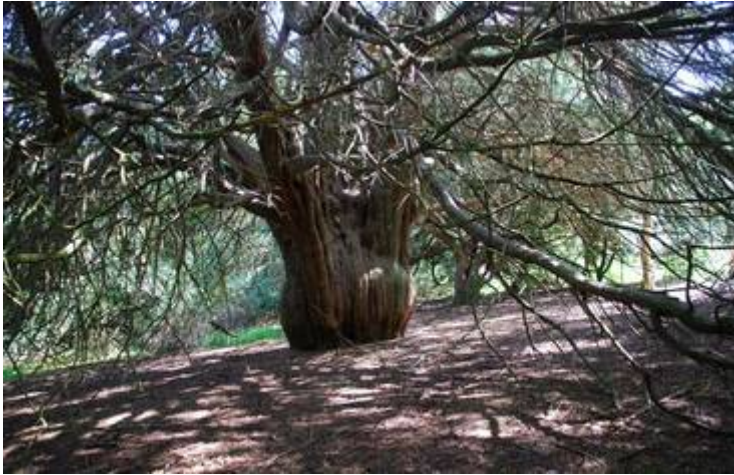
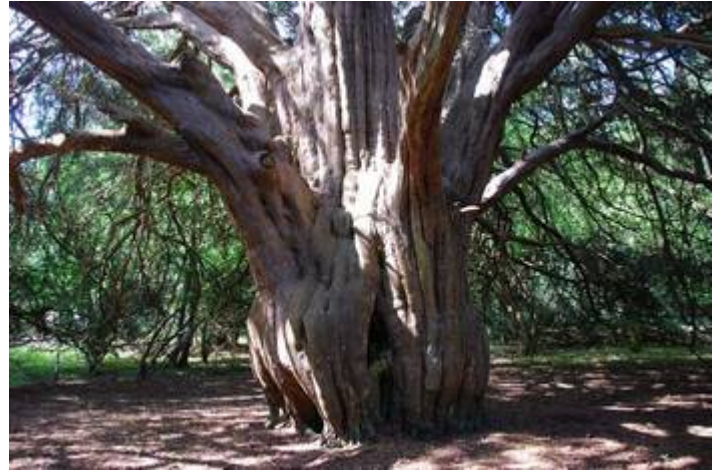
TQ0421449971 M 20' at 6"

Sparse foliage also another example of a cut branch and new wood

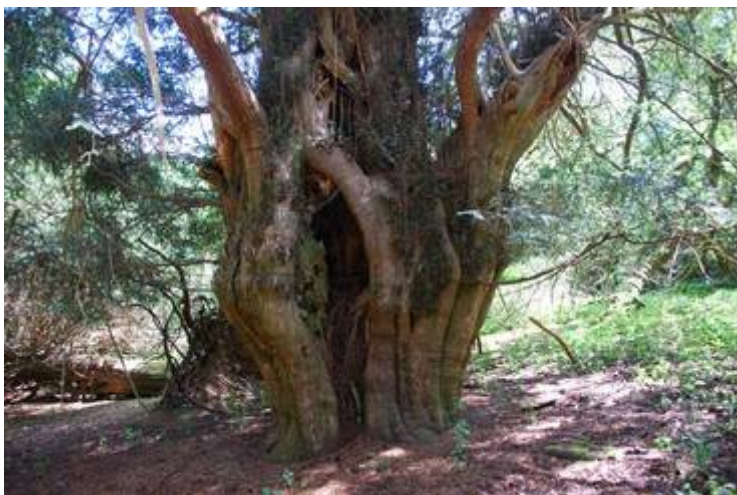
TQ0424150002 F 10' 9" at root crown

Hollowing, internal stem, cut branch and new wood

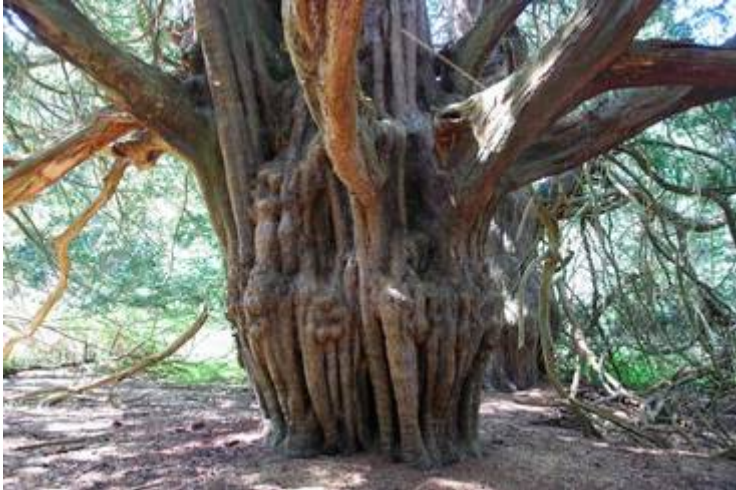
76	<a href="#">TQ0424450005</a>	Merrow	Male	16		4.877	Root crown	Hollowing, fragmented, sparse foliage
77	<a href="#">TQ0423850022</a>	Merrow	Female	15	2	4.623	Root crown	Hollowing
83	<a href="#">TQ0424350174</a>	Merrow	Male	13	10	4.216	1'	
91	<a href="#">TQ0418749992</a>	Merrow	Female	10	8	3.251	1'	Large amount of rot - smaller yew in similar state close by
92	<a href="#">TQ0418249976</a>	Merrow	Male	14	6	4.420	Root crown	has had the ability to grow new bark underneath the old bark and rotted cambion. FC (AH) to be contacted to confirm if this has been noted before
95	<a href="#">TQ0414150016</a>	Merrow	Female	13	1	3.988	1'	Note the mass of broken seed - In all probability this is a larder hoard for a wood mouse
97	<a href="#">TQ0410449942</a>	Merrow	Female	15	11	4.851	1'	
105	<a href="#">TQ0421950139</a>	Merrow	Male	16	10	5.131	Root crown	Large basal cavity, totally hollow. Cramped space to take photographs

TQ0424450005 M 16' at root crown  
Hollowing, fragmented, sparse foliage, loss of branches, small internal roots

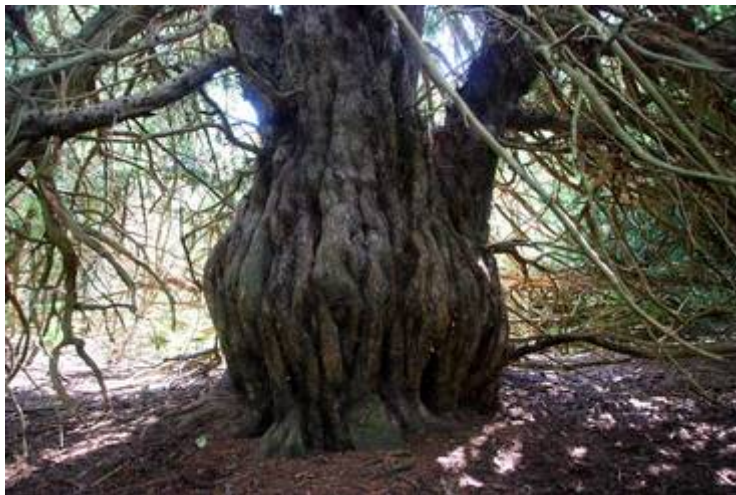
TQ0421950139 M 16' 10" at root crown  
Major loss of outer shell and totally hollow

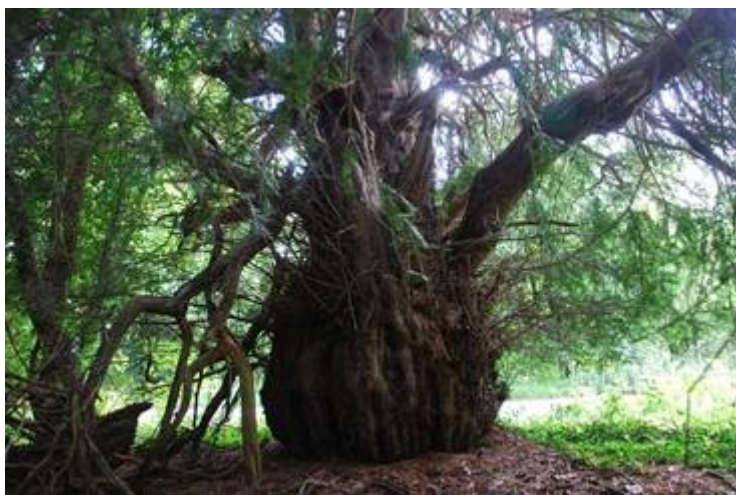
107	<a href="#">TQ0417549616</a>	Merrow	Female	22	10	6.960	Ground	Roadside yew, Difficult to measure due to lower twiggy growth, girth recorded should only be used as an indicator
132	<a href="#">TQ0418849615</a>	Merrow	Male	17	8	5.385	Root crown	Roadside yew, hollow with loss of outer bole, no internal stem, 2 small basal cavities close to the ground.
119	<a href="#">TQ0339149194</a>	Newlands	Female	15	5	4.699	Root crown	Urn shape, hollow and in 3 sections, large central stem that girthed 4' 2" at 1' 6" from the ground. 2 embedded nails, grows close to footpath
120	<a href="#">TQ0340849202</a>	Newlands	Female	11	11	3.632	Root crown	Hollow, major loss of outer bole, no internal stem
122	<a href="#">TQ0333349176</a>	Newlands	Male	15	7	4.750	Root crown	Major branch loss, fragmented with 2 main sections, grows on the linear bank (parish boundary) Undulating tape to get min girth.
123	<a href="#">TQ0325649138</a>	Newlands	Male	12	6	3.810	1' 6"	3 segments, hollow, close to the west carpark

TQ0417549616 F 22' 10" at ground  
Roadside yew, difficult to measure due to lower twiggly growth, tape was threaded behind but girth recorded  
can only be used as an indicator

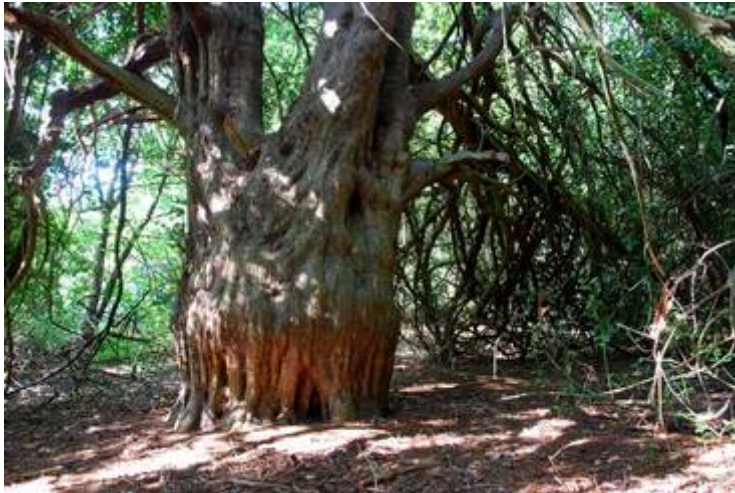
TQ0418849615 M 17' 8" at root crown

Roadside yew, hollow with loss of outer shell, no internal stem and 2 small basal cavities close to the ground

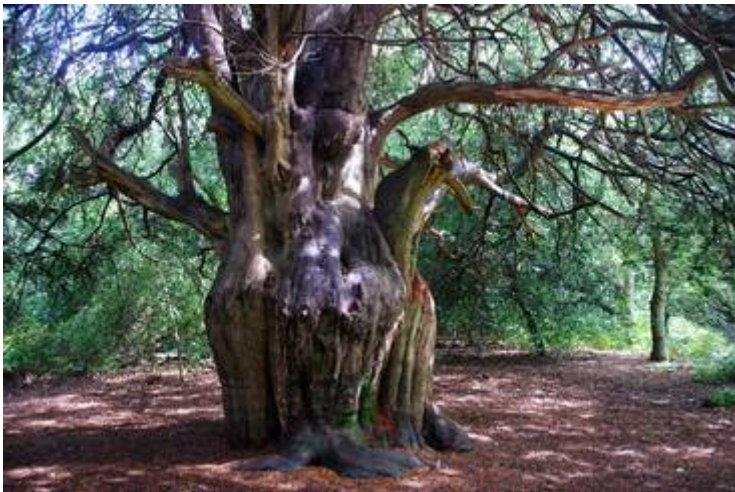
TQ0339149194 F 15' 5" at root crown

Urn shape, hollow and in 3 sections, large central stem that girthed 4' 2" at 1' 6" from the ground, 2 embedded nails, grows close to footpath

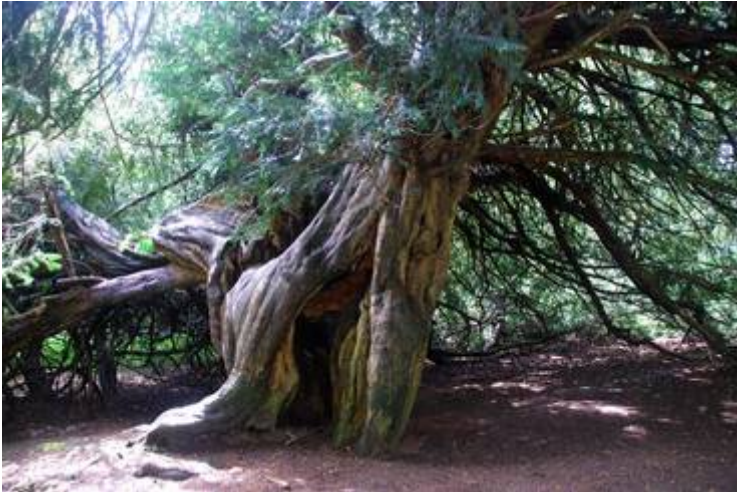
TQ0333349176 M 15' 7" at root crown and ground  
Major branch loss, fragmented with 2 main sections, undulating tape to get minimum girth, grows on the linear bank (parish boundary)
